Dewberry

Facility Assessment Report

Decatur Fire Department

City of Decatur, Illinois Final Report: February 22, 2016

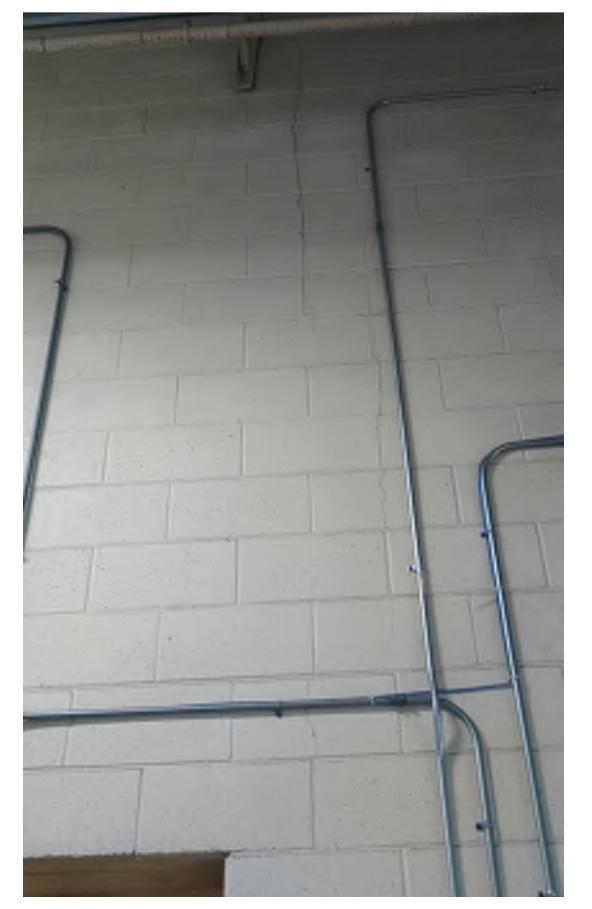
Figure #1-2 Vertical shrinkage cracking in mortar joints and through CMU.

Regarding the CMU walls, some horizontal and vertical cracking was noted at a partition wall in the service area but is not of concern. Some vertical cracking in the mortar joints in the apparatus bay bearing wall above a lintel bearing location. This cracking is suggestive of shrinkage due to inadequate control joints. Throughout the apparatus bay, there are some noted minor stair step cracks indicative of minor differential settlement. Minor differential settlement (inconsistent settlement) in structures can be common and is generally not a cause of concern.

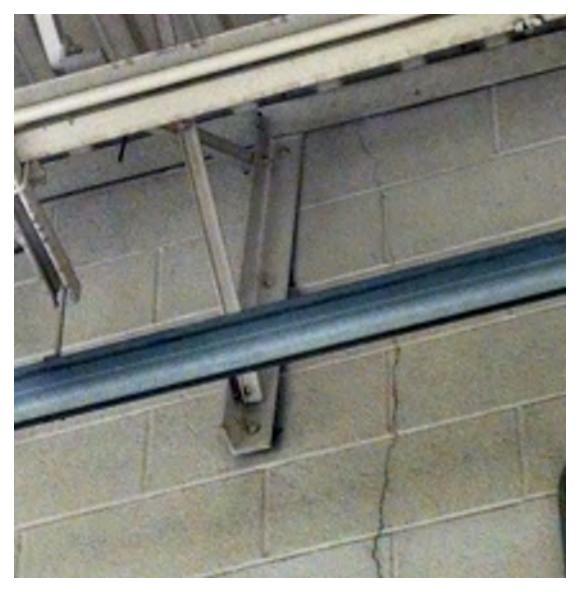
Overall, the structure is in good condition. The building slab is in good condition with the only noted damage to be a few cracked slabs in the apparatus bay. No noted heaving has occurred and the location suggests the damage is due to shrinkage. The structural steel framing and floor system was noted to be in good condition. The steel bar joists and roof deck were noted as being in good overall condition. There is one location of bar joist bridging along the eastern wall of the apparatus bay where the post-installed anchor pulled out of the CMU.

Figure #1-3 Joist bridging anchor pulled from wall.

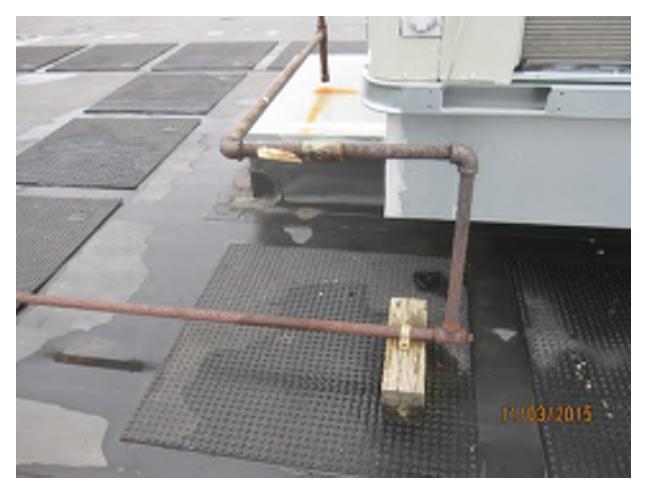
Figure #1-6 Roof top gas pipe supported by wood block.

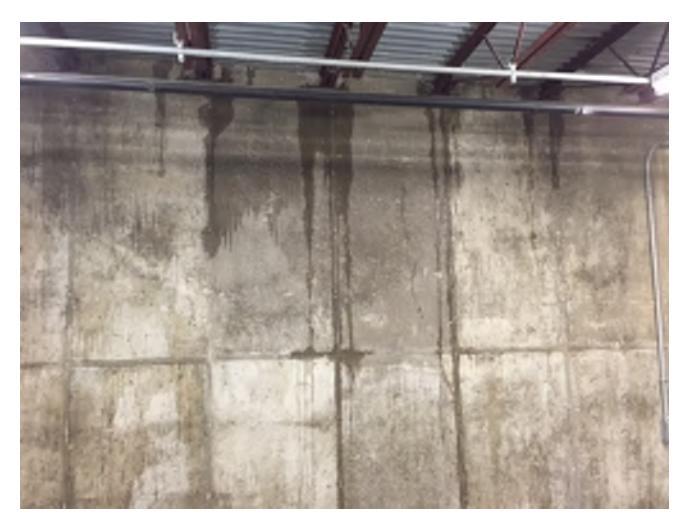
The basement is experiencing water infiltration whenever there is significant rain fall. From the information provided by the occupants and pictures taken during a rain fall event, water infiltrates into the basement at any foundation wall penetration where it is an exterior wall, at beam and bar joist pockets at the top of the foundation walls, and some other locations along the top of the wall. There doesn't appear to be as much water infiltration where the foundation wall isn't a floor joist bearing wall and the joists run parallel to the wall. However this could also indicate water is collecting elsewhere. It seems clear that the main source of the water infiltration is coming from the brick veneer cavity wall system.

Figure #1-17 Water infiltration into basement.

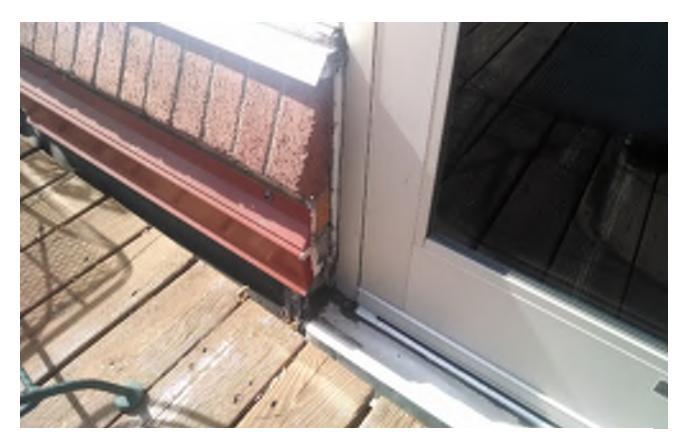
Where exterior doors exit onto the roof or roof patio deck, the roof termination does not wrap and return into the door jamb. Likewise the sill of the door is less than 8" above the roof and the membrane does not terminate under the door sill. This is a potential spot for water infiltration.

Figure #1-20 Exposed masonry at door jamb of second floor patio of Station #1.

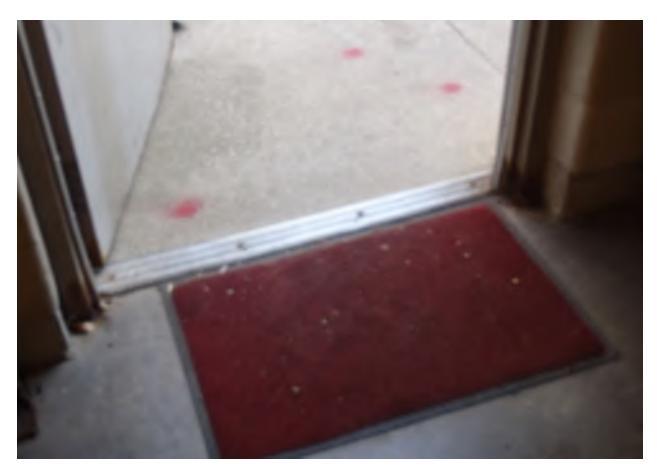
Some hollow metal doors and frames are rusting or beginning to rust at the base of the doors and jambs.

Figure #1-27 Base of door and frame rusting.

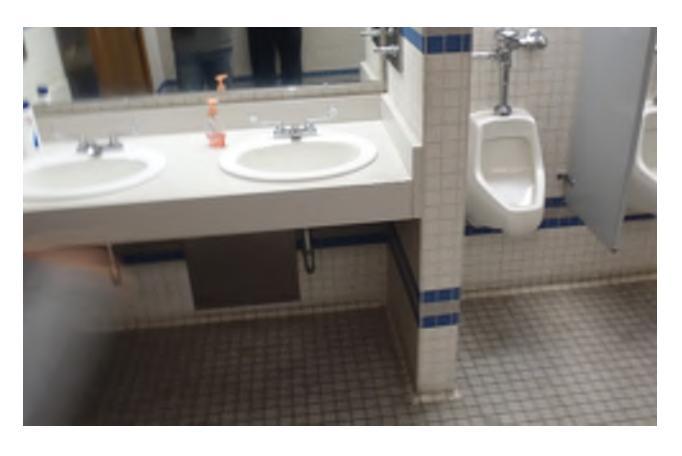
The plastic laminate countertops are beginning to warp from water damage and the sealant at the joint against the wall is failing.

Figure #1-33 Restroom countertops are warped.

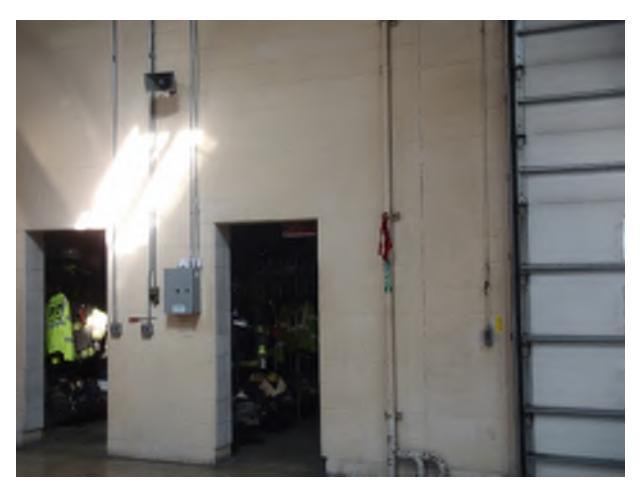
The paint on the walls is fading or discolored. In a few locations the paint is peeling.

Figure #1-37 Apparatus bay CMU walls stained and discolored.

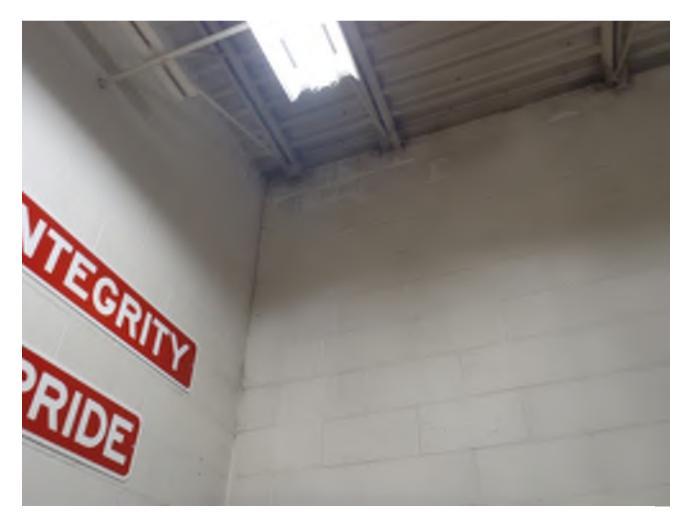
At exterior walls there is evidence of water infiltration at the roof bearing locations. This is addressed in the Roofing and Building Envelope sections.

Figure #1-39 Water infiltration at exterior perimeter walls.

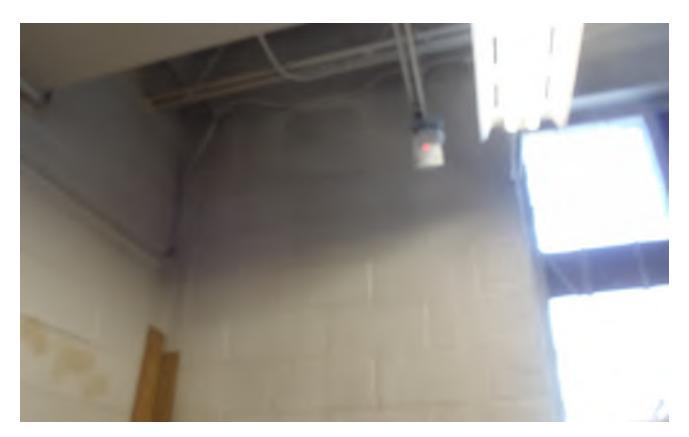
The paint on the walls is fading or discolored. In a few locations the paint is peeling.

Figure #1-40 Discolored CMU and evidence of water infiltration at exterior wall.

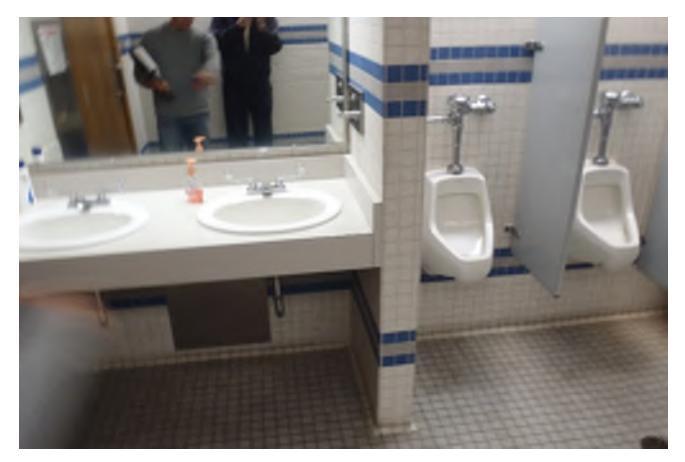
Figure #1-44 Lavatories and countertops do not meet accessibility requirements.

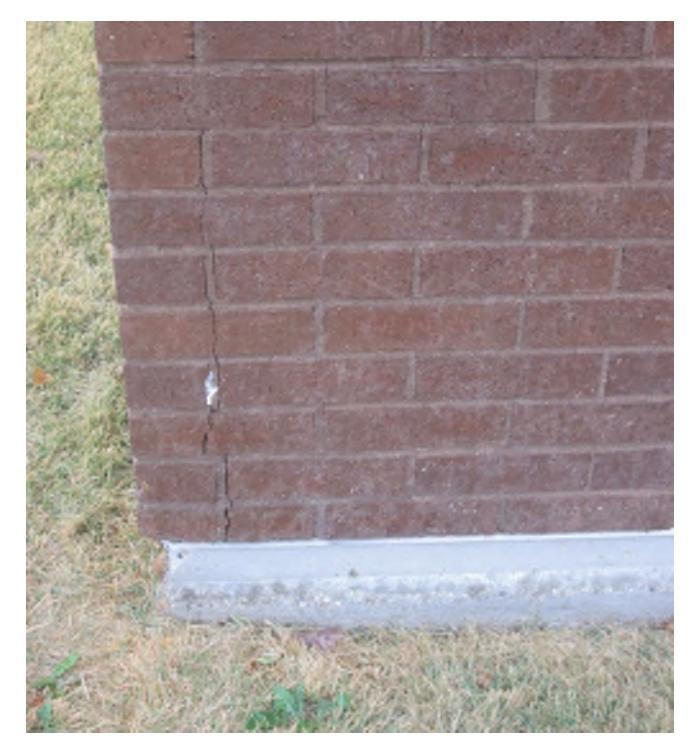
Masonry construction has drip edge at base of wall with regularly spaced weeps and thru wall flashing providing drainage of the cavity wall. However, at the clerestory of the apparatus bay where the roof terminates at the masonry wall drip edge, there was evidence of water infiltration on the interior of the Apparatus Bay.

Figure #2-10 Crack at corner of building due to masonry expansion

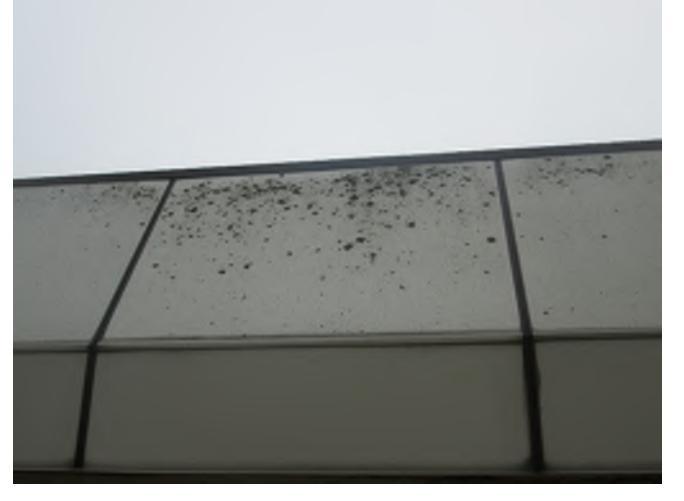
Figure #2-12 Metal panel with organic growth.

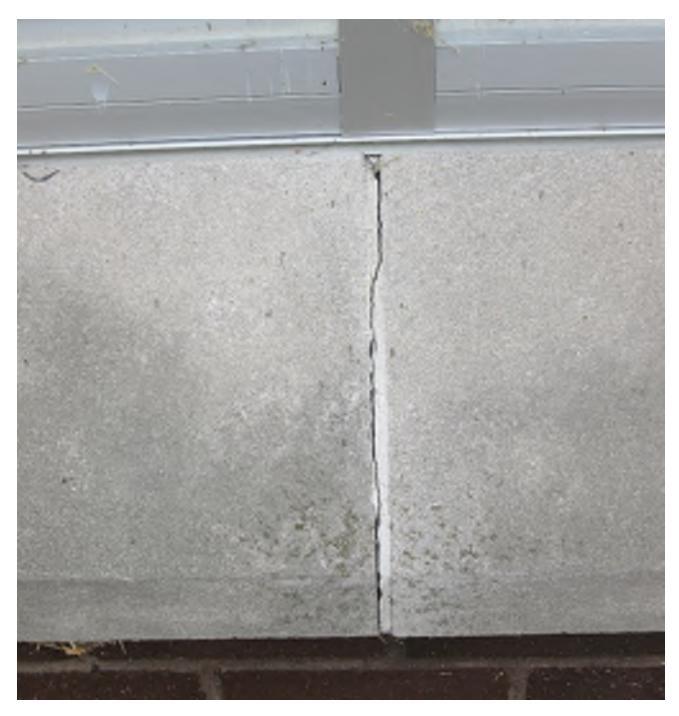
Figure #2-13 Mortar join failure at stone sill.

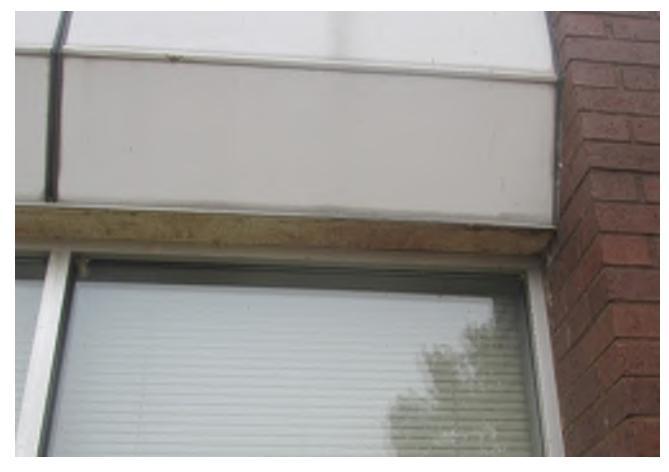
Steel lintels above all the windows are rusting.

Figure #2-14 Rusted steel lintel.

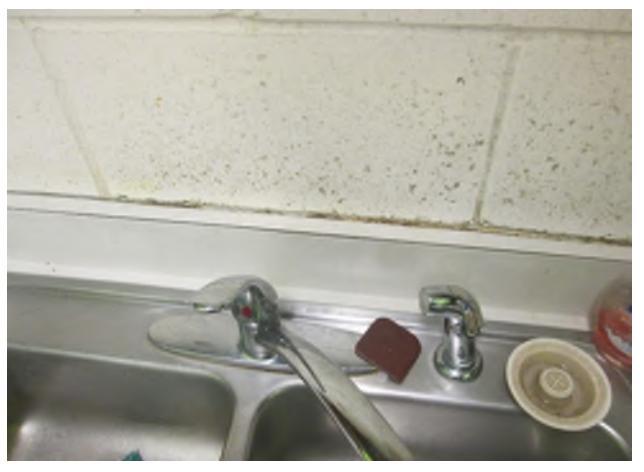
Some of the countertop plastic laminate is delaminating at the backsplash and some plastic laminate is chipping along the edge.

Figure #2-21 Delaminated plastic laminate at back splash.

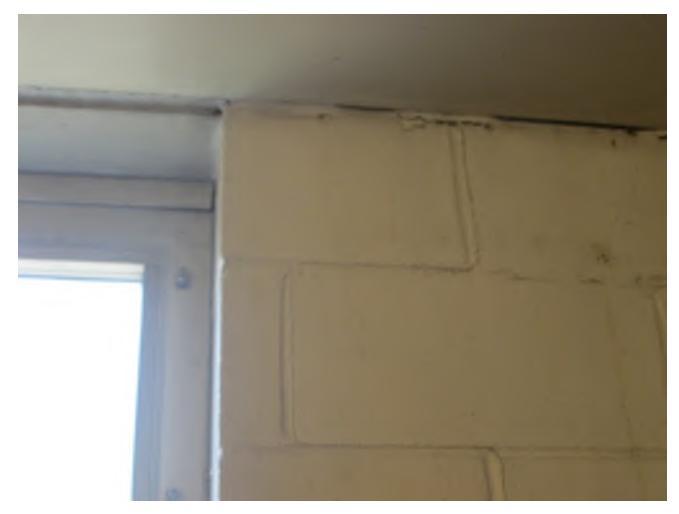
There is evidence of water infiltration at exterior walls at the ceiling causing some staining on the CMU. There are also shrinkage cracks on exterior CMU. Some cracks have formed on the gypsum wallboard ceiling. At the entrance to the shower area the steel lintel is rusting.

Figure #2-22 Water infiltration at exterior wall.

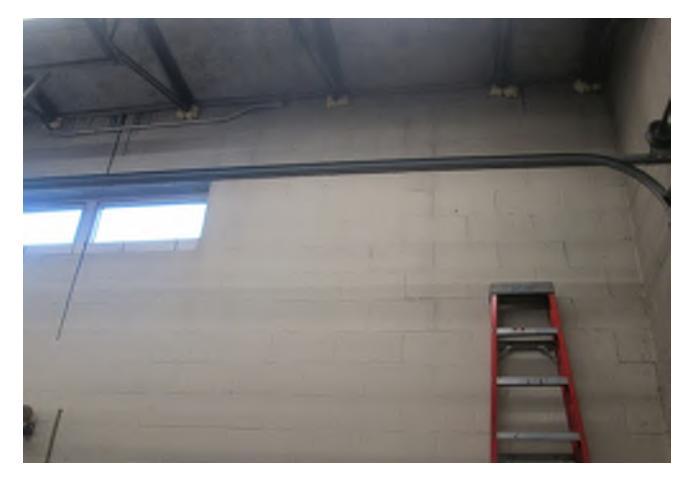
At exterior walls there is evidence of water infiltration at the roof bearing locations. This addressed in the Roofing and Building Envelope sections.

Figure #2-24 Water infiltration and CMU cracking.

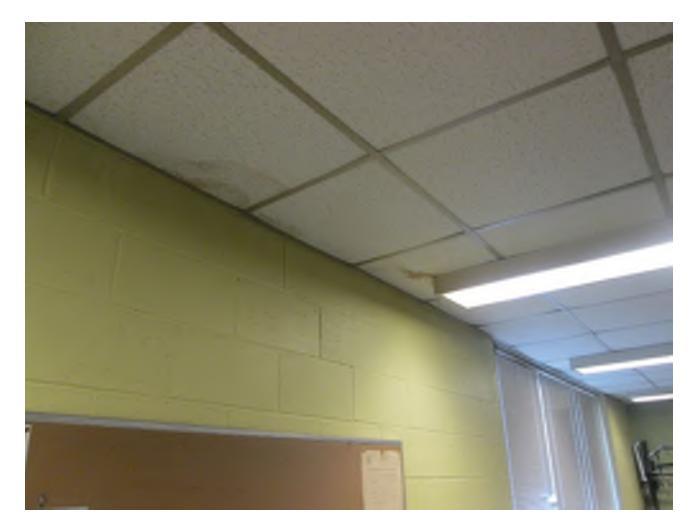
Figure #2-25 Stained ceiling tile in Recreation Room at exterior wall.

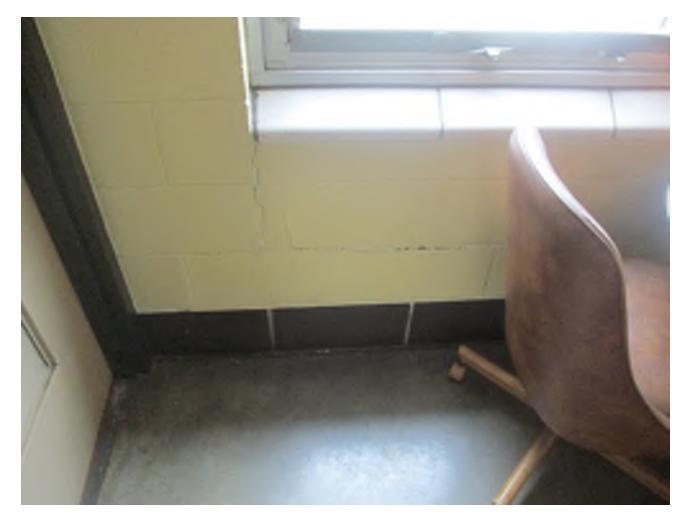
CMU is cracking around sill of window and in other locations at exterior wall.

Figure #2-26 CMU cracking.

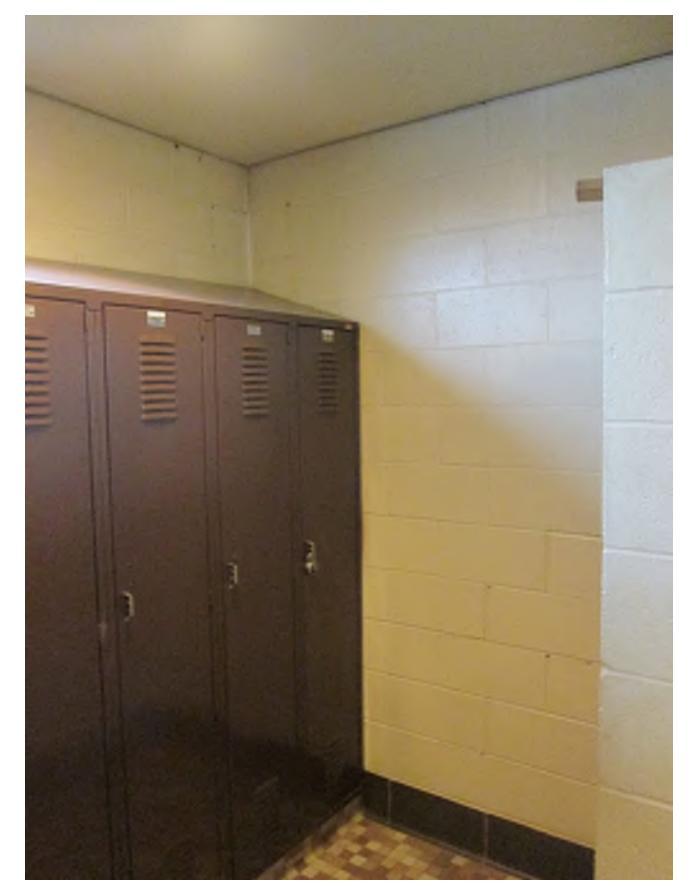
There is evidence of water infiltration at exterior walls at the ceiling causing some staining on the CMU. There are also shrinkage cracks on exterior CMU. Some cracks have formed on the gypsum wallboard ceiling. At the entrance to the shower area the steel lintel is rusting.

Figure #2-27 Water infiltration and CMU cracking.

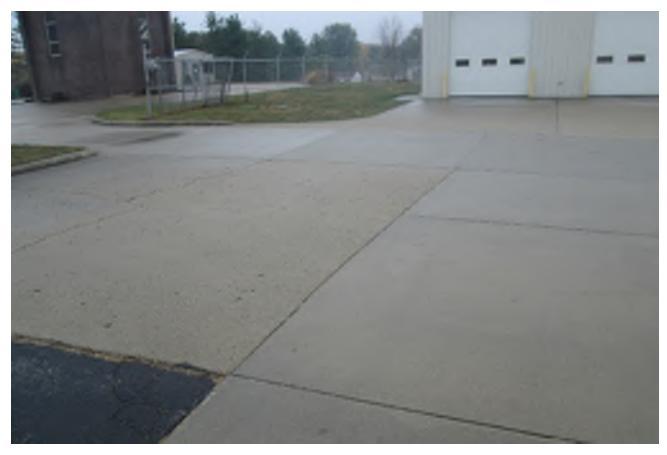
Most of the site concrete is in good condition, but a few sections have a worn surface with exposed aggregate and full length cracks. Exposed aggregate tends to increases the possibility of spalling from freeze/thaw cycles and overall deterioration.

Figure #2-28 Worn concrete paving with exposed aggregate and multiple cracks.

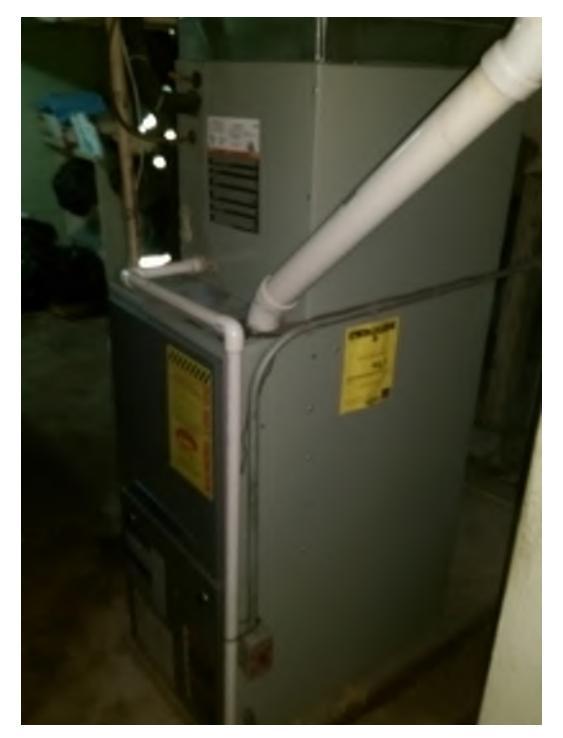
The listed air handling units serving the underfloor duct distribution. The units installed in 2006 are in fair to poor condition and often times is due to the improper filter replacement duration.

Figure #3-4 Station #3 mechanical equipment in basement.

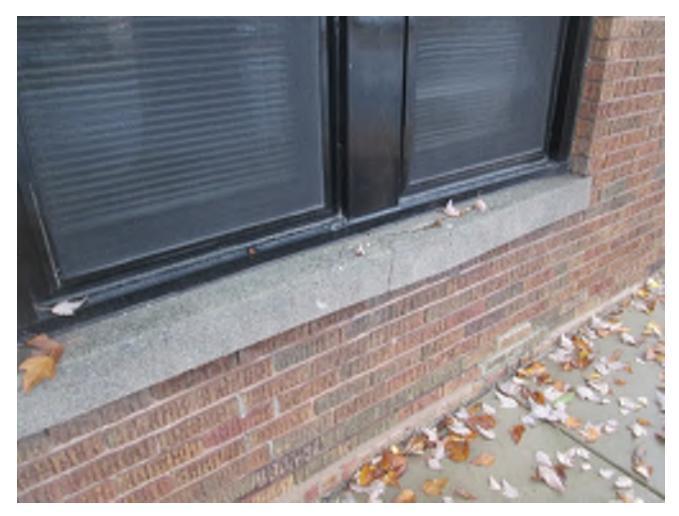
Figure #3-9 Cast window sill is spalling and cracked.

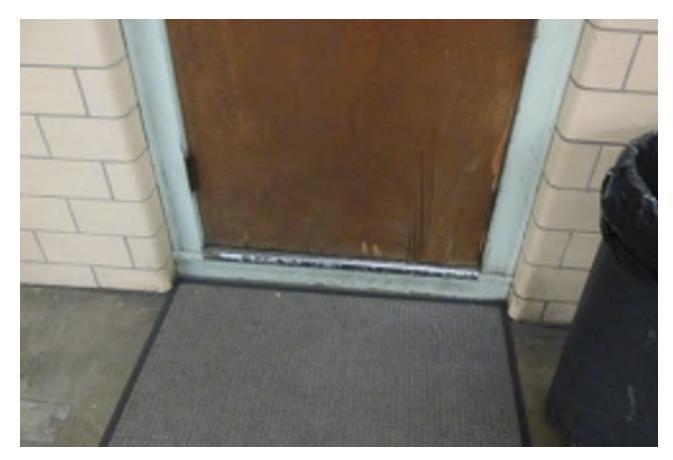
Door from Apparatus Bay into Day Room and Kitchen is worn on the edges from repeated use and doesn't carry any rating.

Figure #3-14 Door from Apparatus Bay into living spaces.

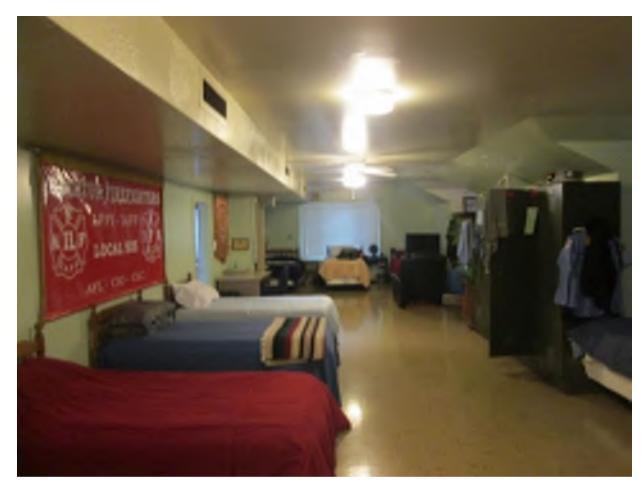
Since the building is essentially residential style construction and layout, there are issues with egress from the 2nd floor Sleeping Quarters as well as construction. The existing stair is not sufficient in size to meet standards for egress and exiting under current life safety codes and building codes. The Sleeping Quarters also lacks a second exit which would be required under current life safety codes and building codes. It should also be noted that current codes typically require smoke and/or fire separation from other spaces particularly the Apparatus Bay.

Figure #3-16 Sleeping Quarters, peeling paint, no secondary exit.

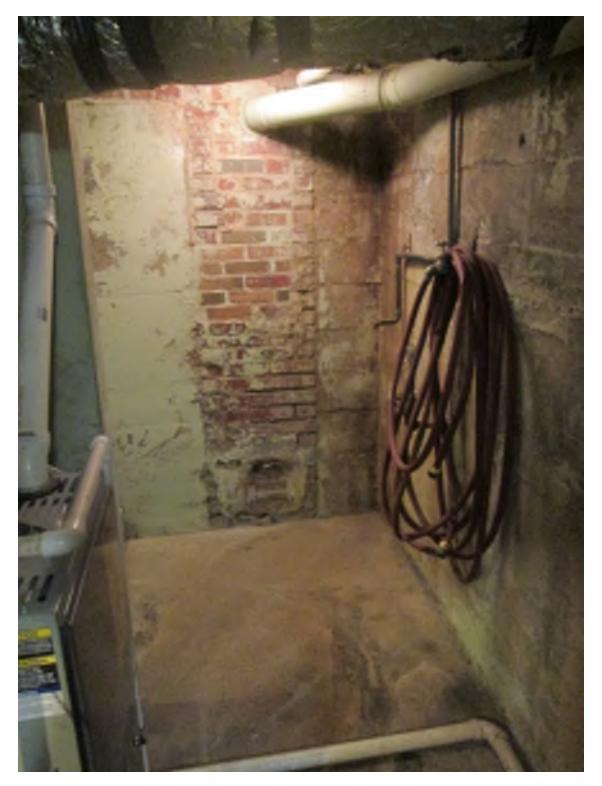
The exterior walls are exposed brick and block. In one location water was infiltrating and coming into the basement due to downspout issue. Work at down spout was completed and infiltration stopped.

Figure #3-17 Basement location where water infiltration occurred.

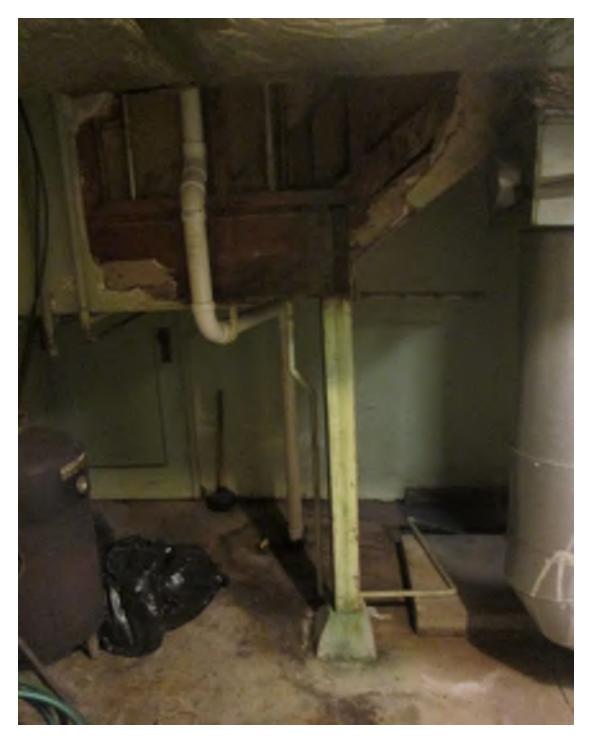
The stair has a 4x4 wood post at the base that is not securely attached to the concrete base.

Figure #3-18 Unsecured 4x4 post.

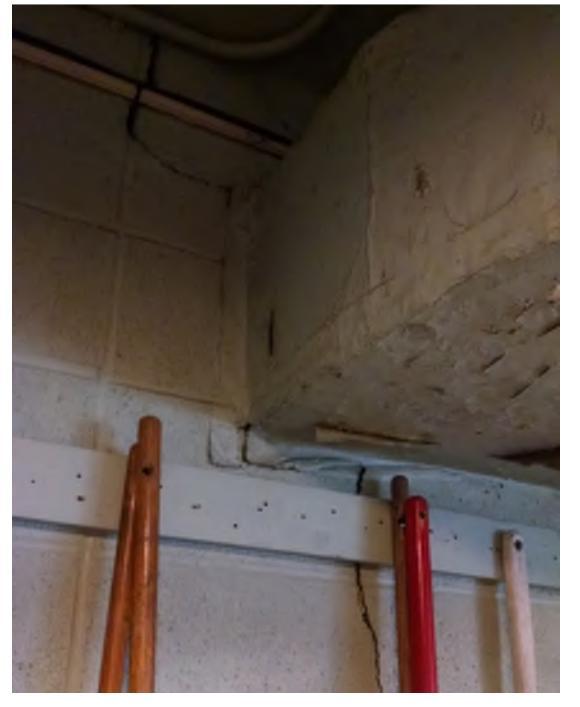
The CMU bearing and partition walls appear to be in good condition with one exception. The wall dividing the Mechanical Storage Room from the Sleeping Quarters has a vertical crack though the block and mortar joints. The bottom course beneath this crack has several spalled sections of block where the wall meets the floor on the Sleeping Quarters side of the wall. The vinyl tile is also curled and heaving at this location, likely an effect of the spalling from the CMU. The location of the cracking coincides with an HVAC duct penetration. The re-entrant corner of a penetration is often a location of heightened stress where cracking is more common. No conclusive cause for the distress can be suggested at this time.

Figure #4-2 Shrinkage crack at duct penetration on CMU wall between Mechanical Storage Room and The Sleeping Quarters.

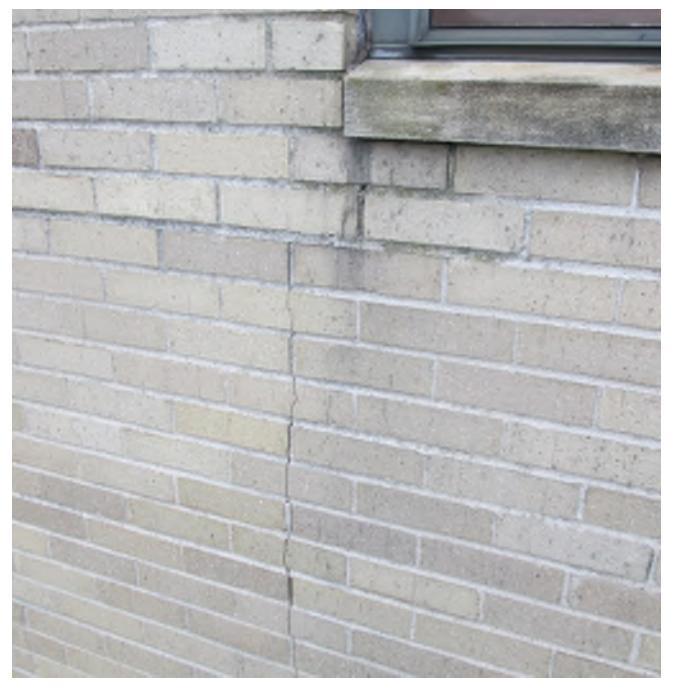
Figure #4-10 Crack at corner of window.

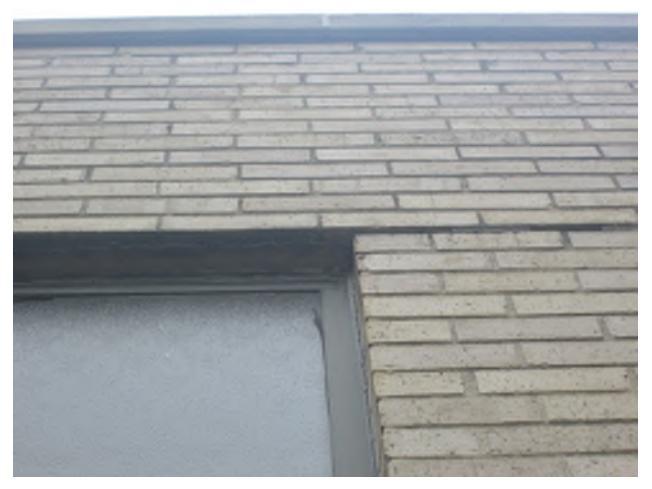
At lintels above openings, mortar is loose and failing. The flue and parapet walls above roof also have failing mortar joints. There are some places where mortar is delaminating or no longer bonded with brick. Typically repointing of mortar joints for buildings is needed after 50 years.

Figure #4-11 Mortar failure at lintel. Rusted steel lintel.

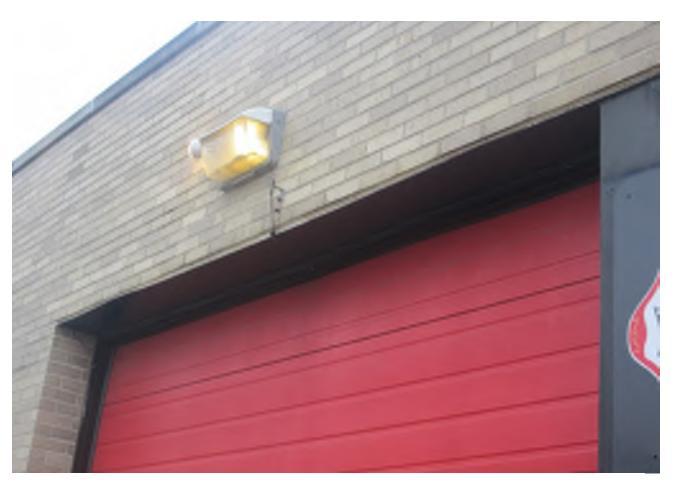
Lintels above overhead doors are severely rusted with some sagging. It is likely that the brick is not bearing on steel lintel plate and is dependent on 'arching' of the running bond pattern.

Figure #4-12 Rusting and sagging lintel.

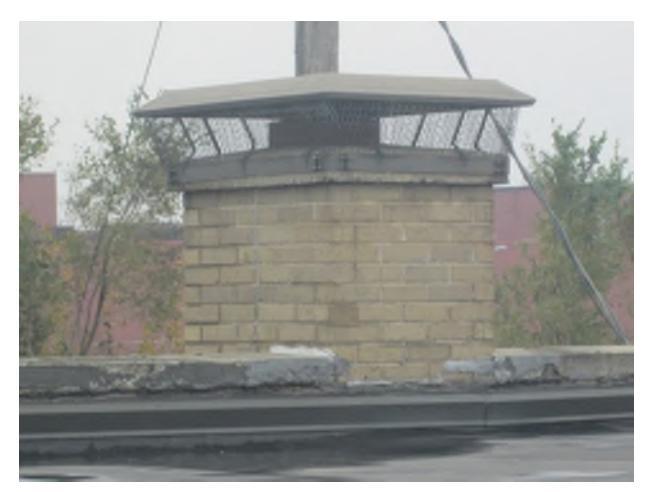
There were some signs of water infiltration on the interior of the Apparatus Bay along the perimeter of the ceiling from possible roof leaks. This could be from before roof replacement or because the roof membrane doesn't lap over parapet coping.

Figure #4-14 Stone coping cap with sealant likely to stop reoccurring water infiltration into Apparatus Bay.

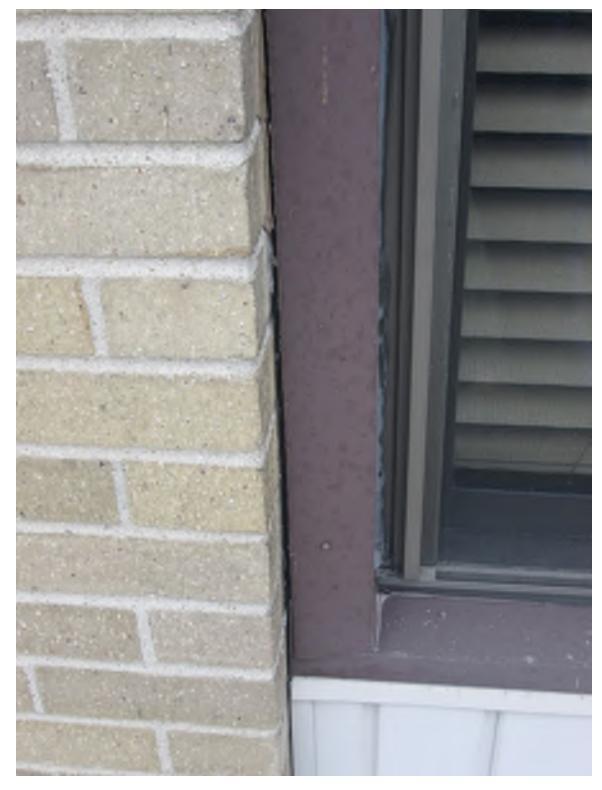
Figure #4-16 Sealant missing at perimeter of opening.

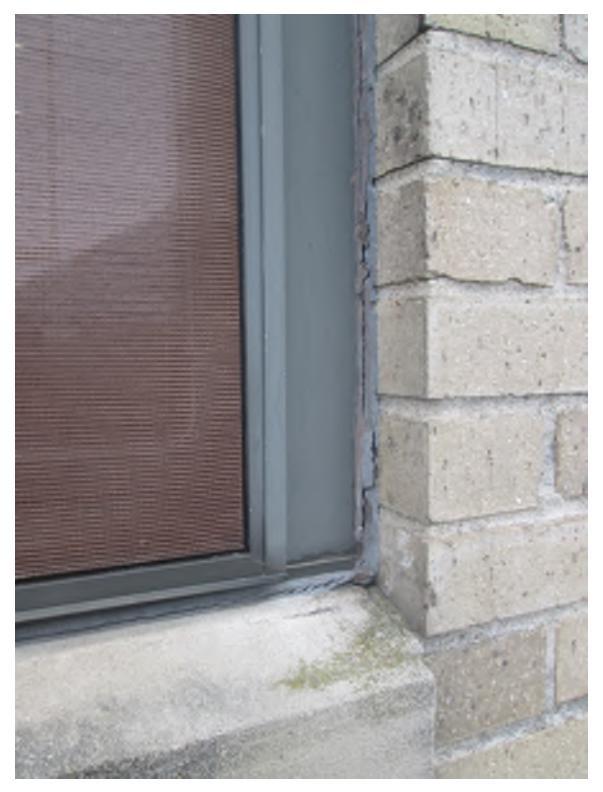
Figure #4-17 Failing sealant.

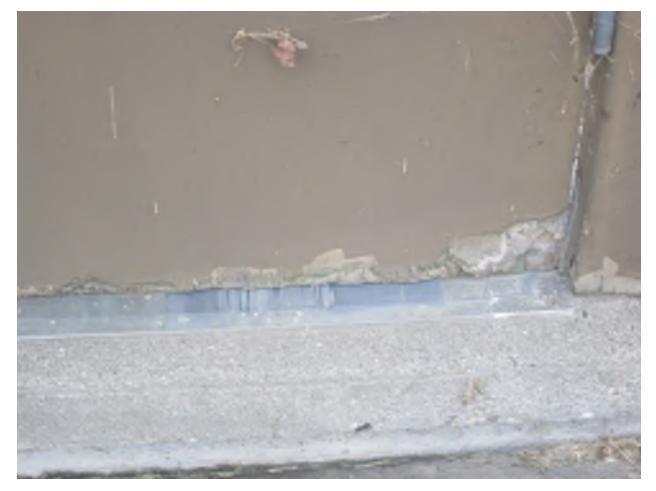
The north exterior door is difficult to open and rubs against the threshold. The base is deteriorating and damaged from use. Door also needs updated weather stripping.

Figure #4-18 Deterioration at base of door.

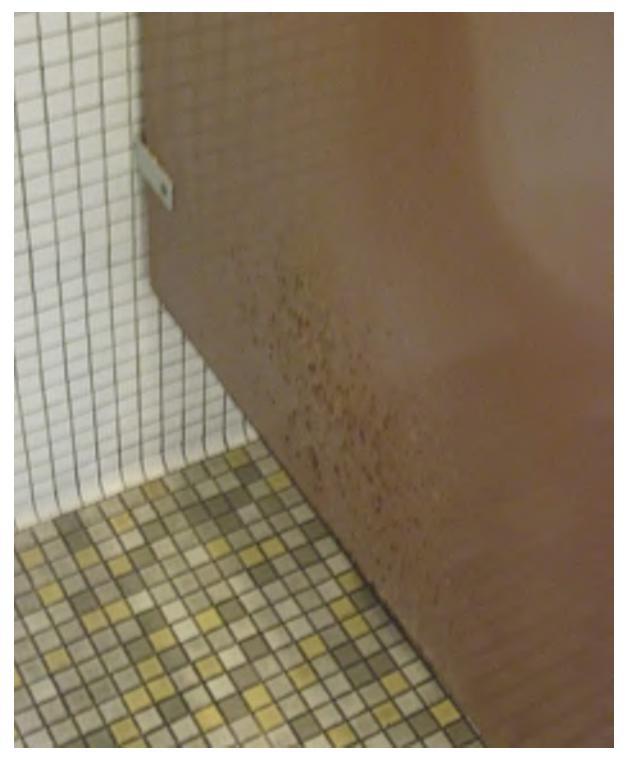
Rust is developing on the side of the toilet partition next to urinal. Some rust is developing on lockers and cabinets.

Figure #4-20 Rust on toilet partition.

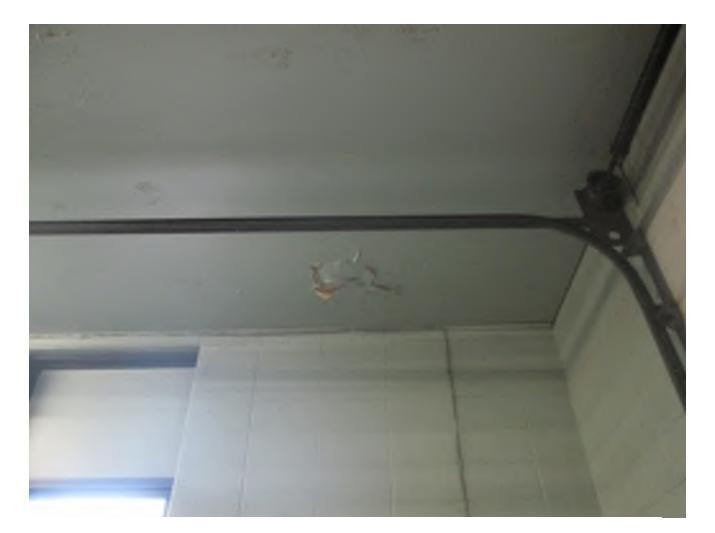
At exterior walls and on the ceilings there is evidence of water infiltration at the roof bearing locations. The leaks are addressed in the Roofing and Building Envelope sections. However, since the space above the hard plaster ceiling is concealed, there is concern of potential mold growth above the ceiling. It should be noted that at Station #5 there was a similar issue and condition at the Sleeping Quarters which revealed a mold issue when the ceiling collapsed and was then removed in its entirety.

Figure #4-24 Water infiltration at perimeter of room, peeling paint.

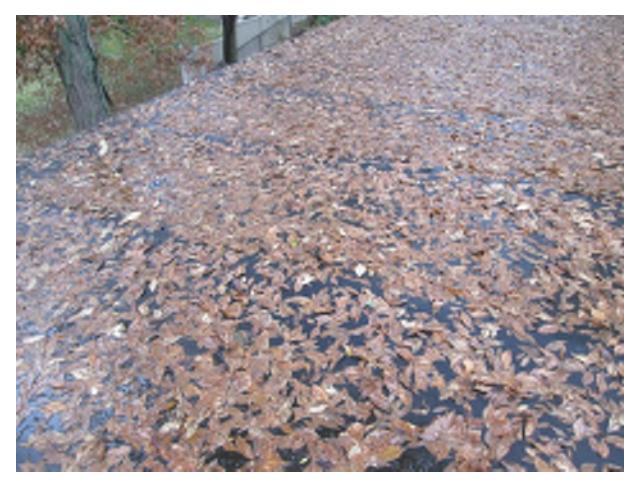
Figure #6-9 Ponding on roof due to insulation failure.

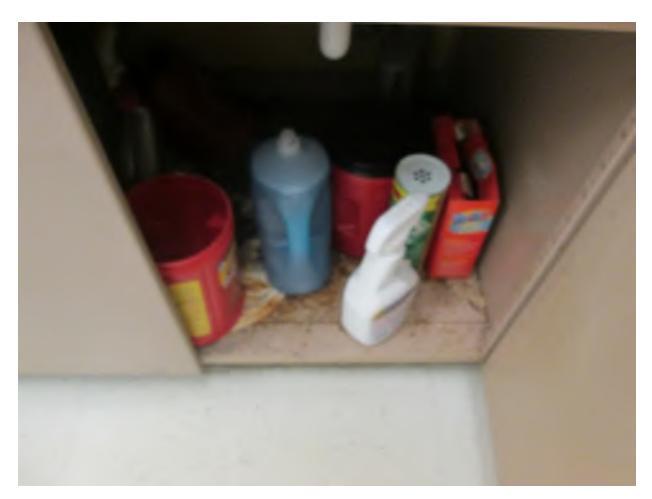
Figure #6-12 Metal base cabinets are rusting.

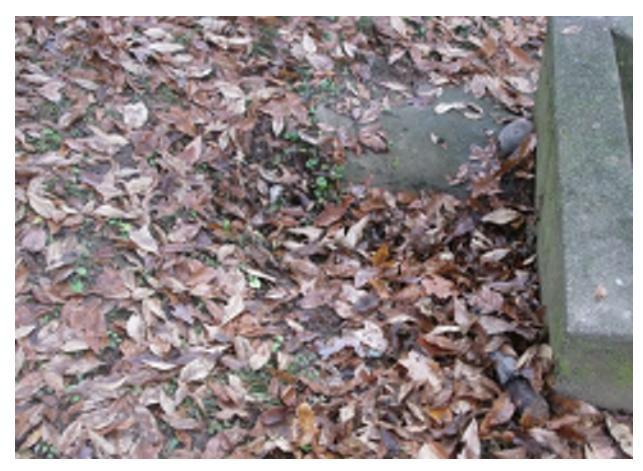
Figure #6-17 Damaged storm water outlet.

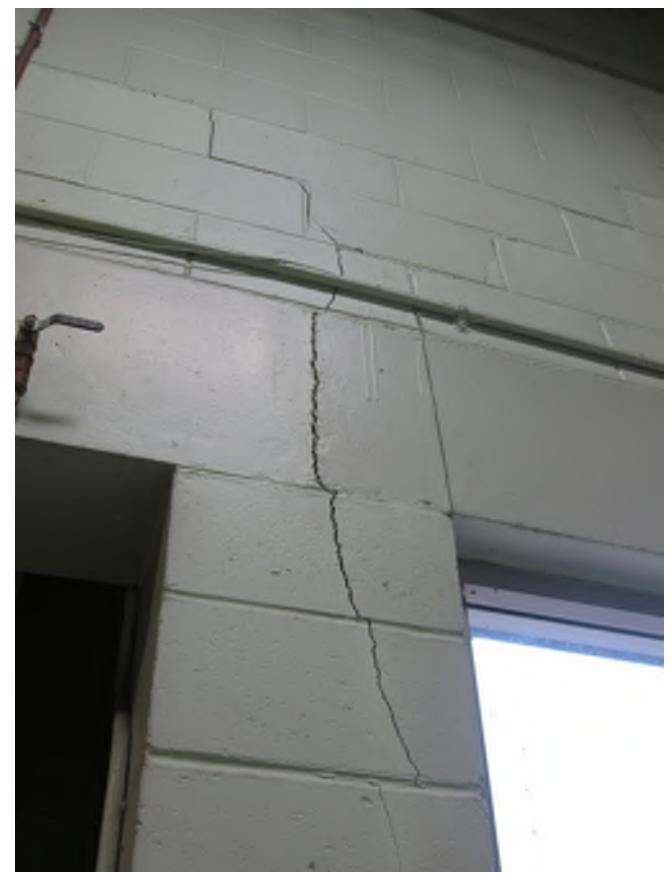
Figure #7-2 Continuous crack through masonry below and above concrete lintel.

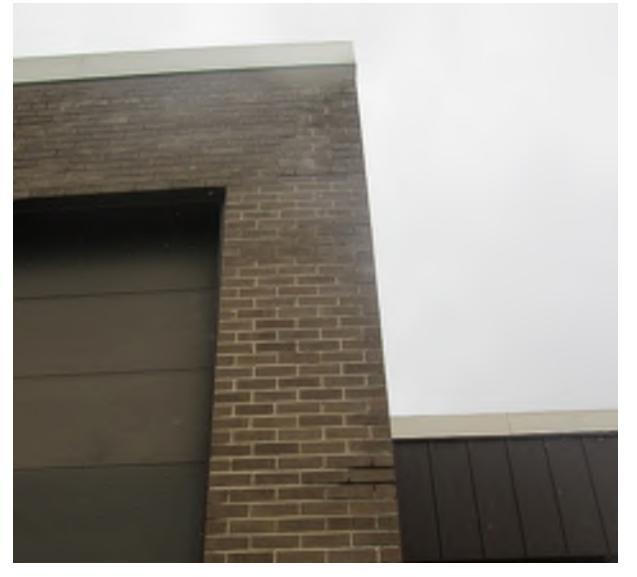
Figure #7-8 Saturated brick with weathered joints and spalling bricks and mortar is evidence of captured moisture.

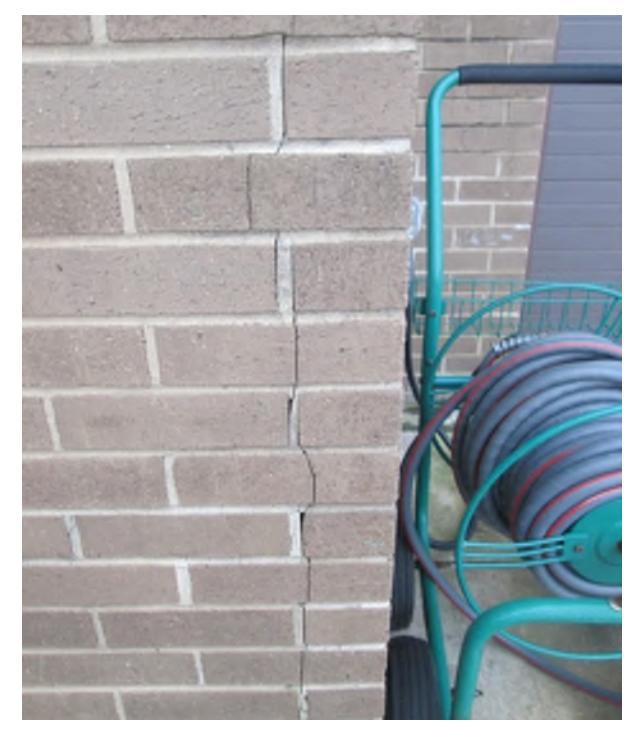
Figure #7-10 No control joints provided in masonry resulting in cracking at corners and at openings.

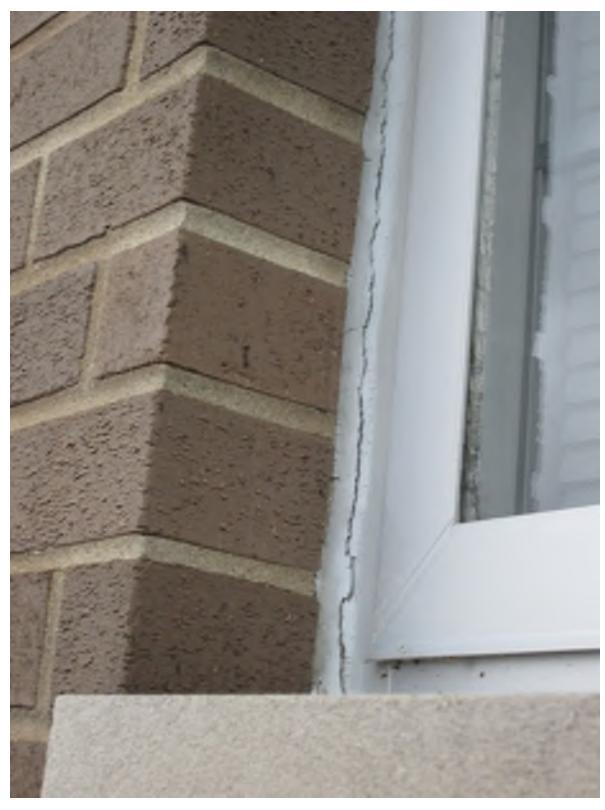
Figure #7-14 Failing sealant at perimeter of openings.

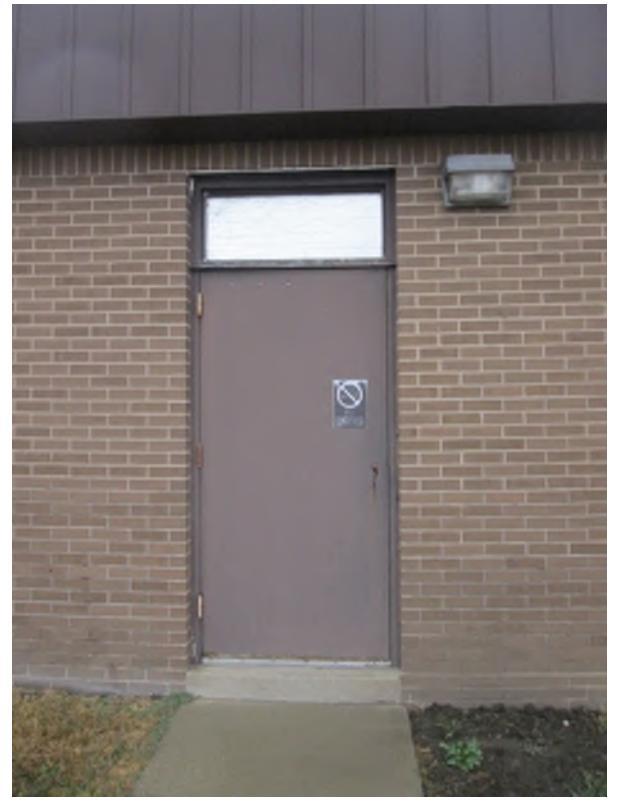
Figure #7-15 Door is rusting with damaged transom panel.

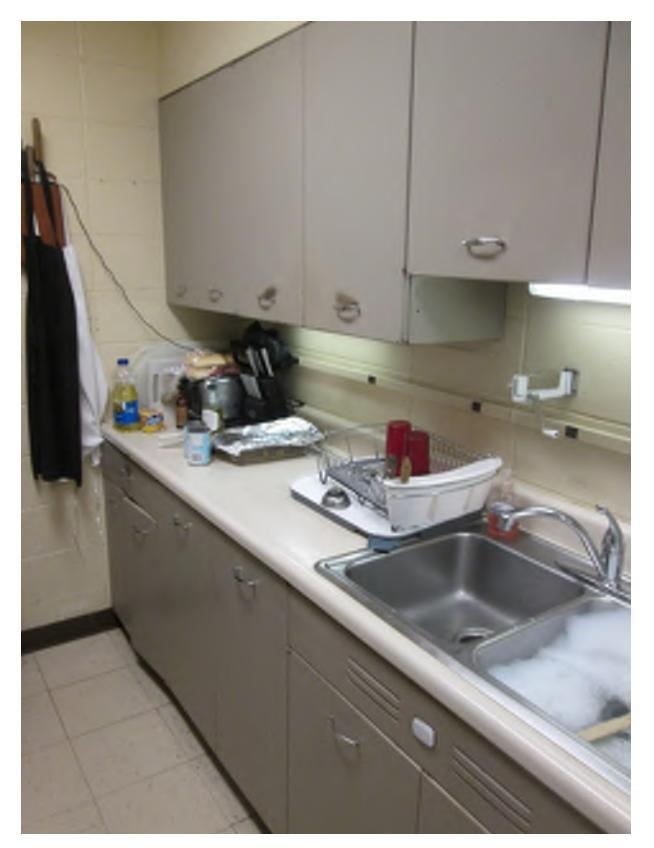
Figure #7-18 Kitchen cabinets are dated and worn from repeated use.

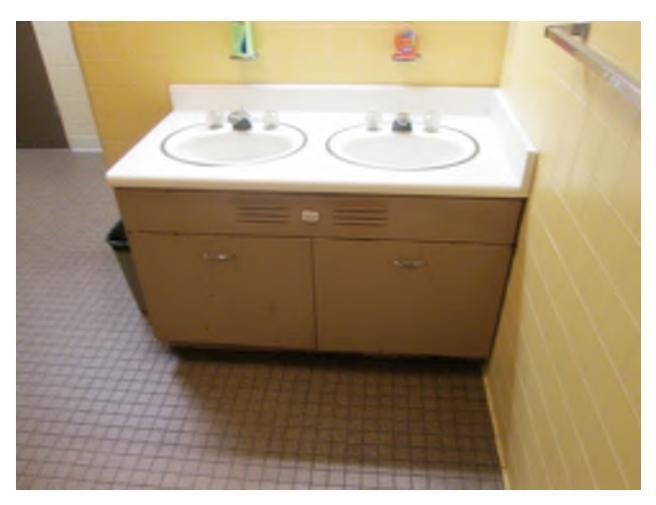
Figure #7-19 Lavatory in Toilet and Locker Room is rusting in the base cabinet.

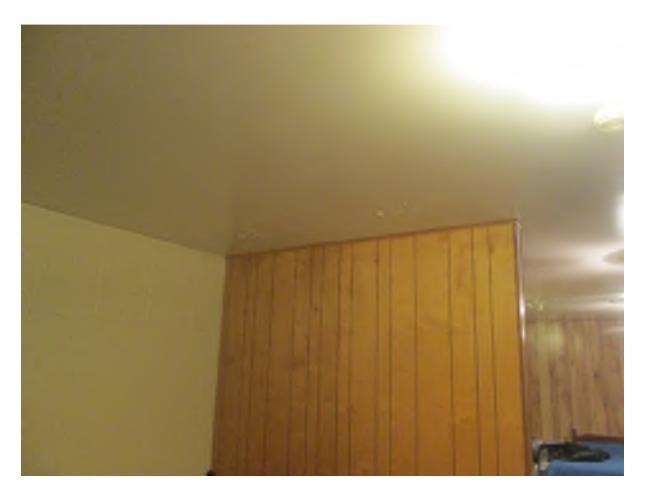
Figure #7-20 Peeling paint in Sleeping Quarters.

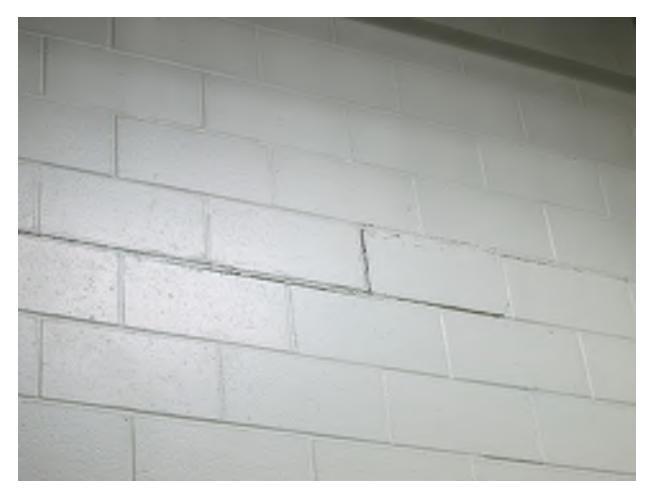
Figure #7-21 Horizontal crack in CMU in Apparatus Bay.

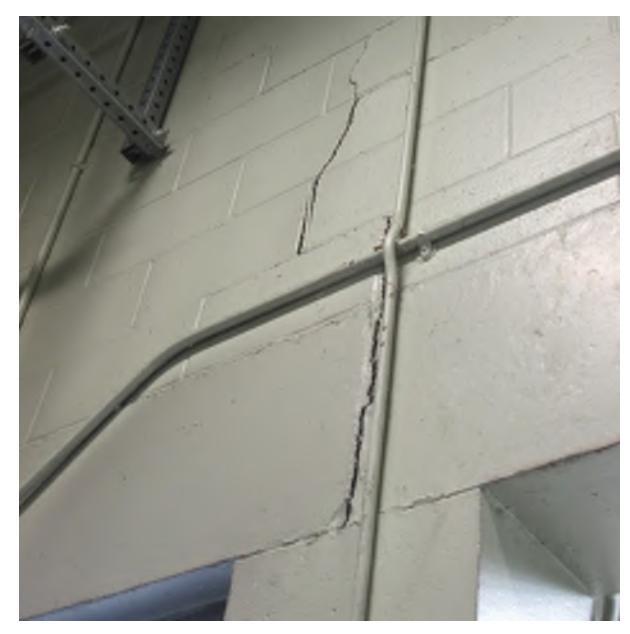
Figure #7-22 Vertical cracks in CMU.

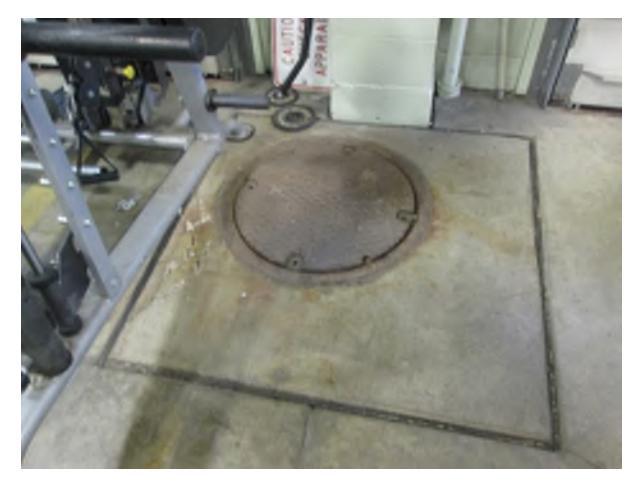
Figure #7-23 Spalling concrete at man hole in Apparatus Bay.
