Dewberry

Facility Assessment Report

Decatur Fire Department

City of Decatur, Illinois Final Report: February 22, 2016

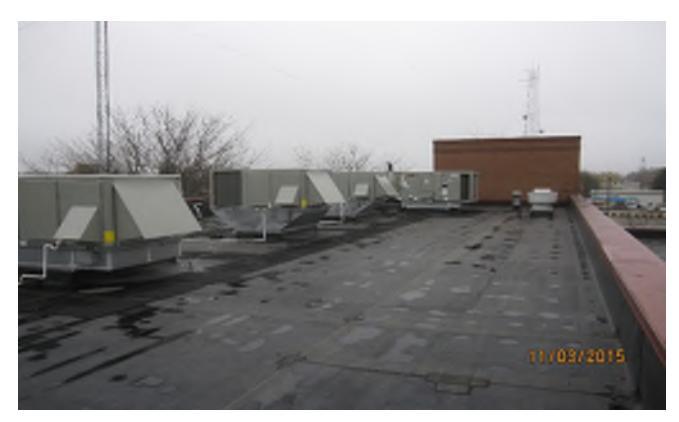
Figure #1-4 Rooftop Units, Dx Cooling, Gas Heating.

The following table shows existing roof mounted equipment and their particular information. the coils clean - (or sooner as required for cleaner air quality). The units also should be checked out for their damper operation for economizer function that saves energy by not having to run compressors when outdoor air temperature is around 55°F. The life of the thermostats is 5 to 8 years and need to make sure they are functioning according to their intended operation. And finally, once in a five year period, consider having the duct system professionally cleaned.

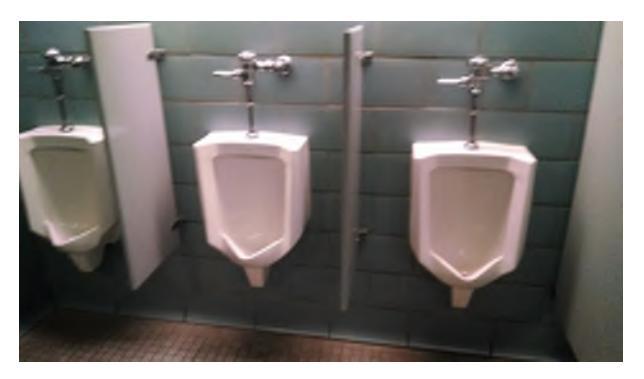
Figure #1-9 Station #1 toilet room urinals.

Urinals and toilets are vitreous china, wall mounted and manufactured by American Standard with Sloan manual flush valves. Lavatories are vitreous china, counter mounted and manufactured by Kohler with manual faucets. Sinks are stainless steel single and double bowl counter mounted with manual faucets. All fixtures appear to be in working order. Water pressure is low at most of the stations fixtures, particularly while equipment is being tested.

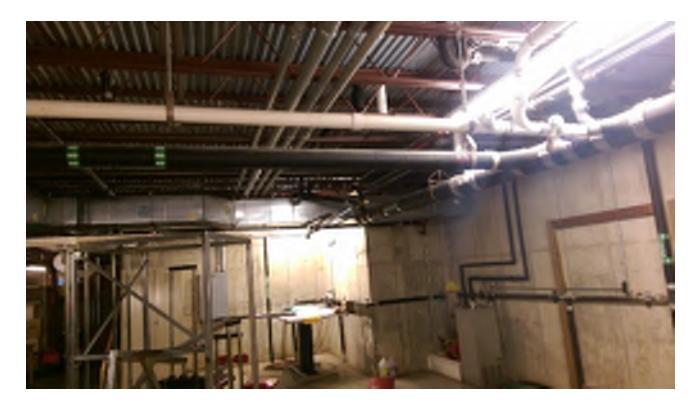
The sanitary sewer in the basement has drainage issues due to insufficient slope at the foundation wall invert leaving the building. The remaining PVC section of pipe at the foundation wall appears to be at an incline creating a low point at the connection between the cast iron pipe and PVC pipe.

Figure #1-10 Sanitary Sewer line in basement of Station #1.

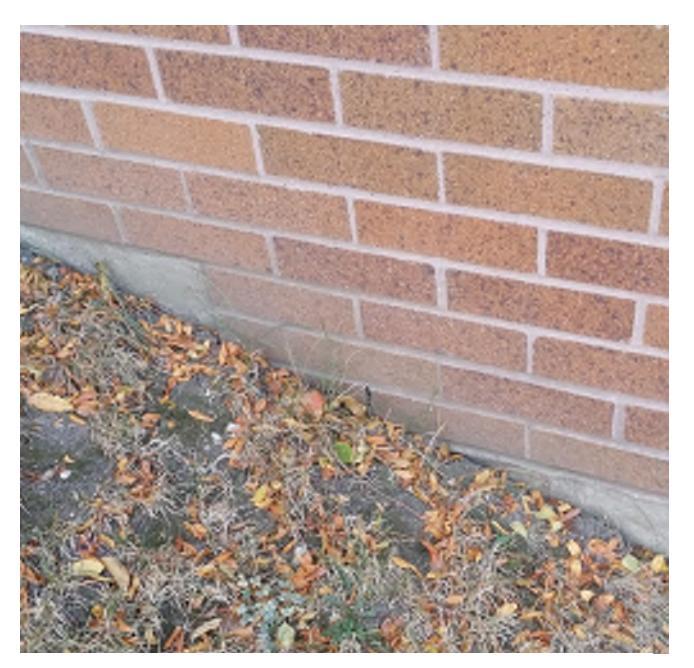
Figure #1-11 Grade covering weeps at base of wall.

The existing wall construction shows consistent weep hole placement at the base of the wall throughout the facility, however there were a few locations where grade was covering the base course of brick and the weep holes. There were also a few locations were weep holes were not provided.

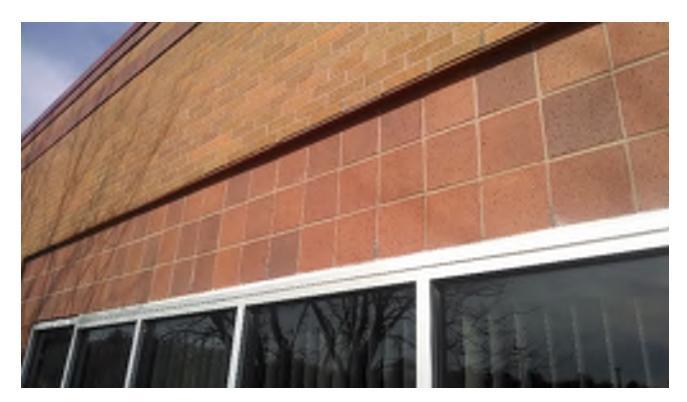
Figure #1-12 Weep holes filled with sealant.

Weep holes are visible at lintels above windows in most locations. However, as a result of some major leaks in the 2nd floor kitchen, many of the weeps have been filled with sealant which were assumed to be the source. From observations, the leaks are likely from another condition and the weep holes should not be filled.

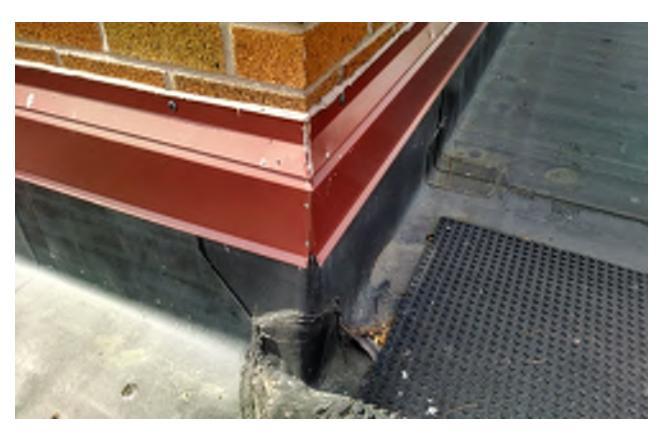
In many locations, the base of the wall and at lintels indicate thru wall flashing without a drip edge. However at roof to wall transitions, there is not visible thru wall flashing in the cavity wall system to prevent water in the cavity from entering the interior of the building. There is only surface mount counter flashing with sealant.

Figure #1-13 Roof to Wall transition condition at Station #1. No thru wall flashing at brick cavity wall construction.

Typically at this condition, thru wall flashing with a drip edge integrates with a 2-piece counter flashing covering roof terminations for a consistent drainage path. These conditions correspond directly with evidence of severe leaks in the interior spaces below. Particularly around the 2nd floor kitchen.

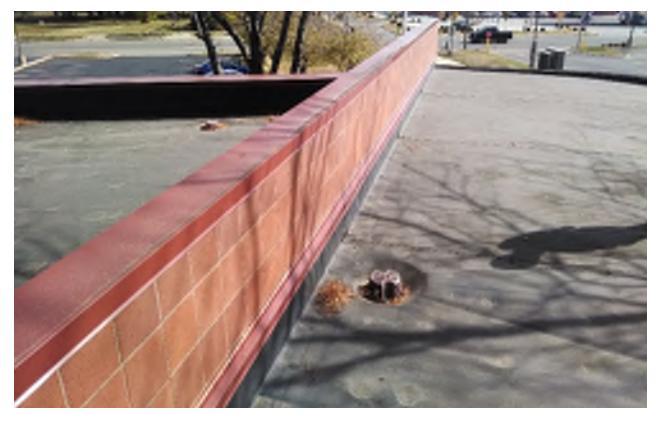
A similar issue is also seen at the tall parapet wall at the main entrance to the building. On the interior there is consistent evidence of efflorescence on the exposed masonry on the interior that extends through the roof as a parapet.

Figure #1-14 Tall parapet wall condition at Station #1. No thru wall flashing at roof termination provided.

The tall parapet wall functions as an aesthetic element for the entrance with a specific purpose in keeping the masonry above the roof line visible. However, the roof detail only provides a surface mount counter flashing into the masonry and a sheet metal coping cap, leaving roughly 42" of masonry wall exposed to absorb water and allow water infiltration into the building. The absorbed water into the masonry is the cause of the efflorescence on the interior.

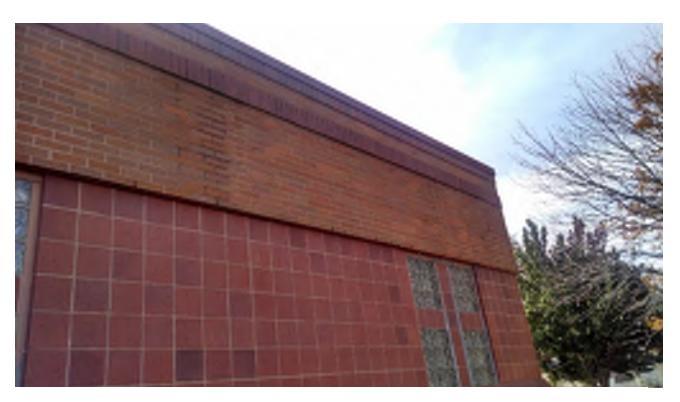
In a few locations on the north side of the building, there is discoloration or a darkening of the masonry indicating the presence of water absorbed into the masonry that is unable to escape through the cavity. Based on drawings provided, a mortar net or means of preventing the mortar from creating water dams in the cavity were not provided which can result in water accumulating in the cavity.

Figure #1-15 Saturated brick masonry is evidence of water in cavity unable to escape.

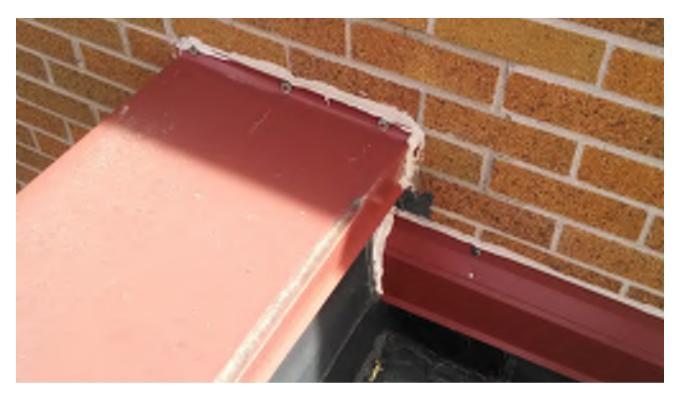
Ends of roof coping capes that terminate into masonry do not have thru wall flashing condition. The joint is simply a bead of sealant or upturned leg with fasteners and sealant. This condition does not provide a means for water to exit before entering the interior.

Figure #1-16 Wall coping cap termination at adjacent wall.

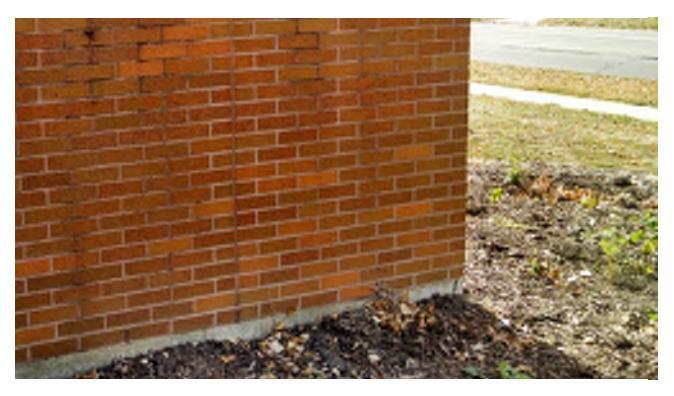
Figure #1-18 Base of wall, no drip edge and open weeps.

It should be noted that the base thru wall flashing was specified to be asphalt coated copper fabric flashing. Visual observations on site could not explicitly confirm this, but there were a few locations where what could be seen appear to confirm this type of flashing. It also should be noted that the base thru wall flashing does not extend to the exterior of the brick and a stainless steel drip edge was not provided. Finally the cavity wall system doesn't appear to be detailed or specified to have a mortar net system to prevent mortar from collecting at the thru wall flashing. Thru wall flashing conditions above windows and lintels likely have similar issues. As a result of the detailing and products specified, these are potential issues that might be the cause or contribute to the water infiltration into the basement:

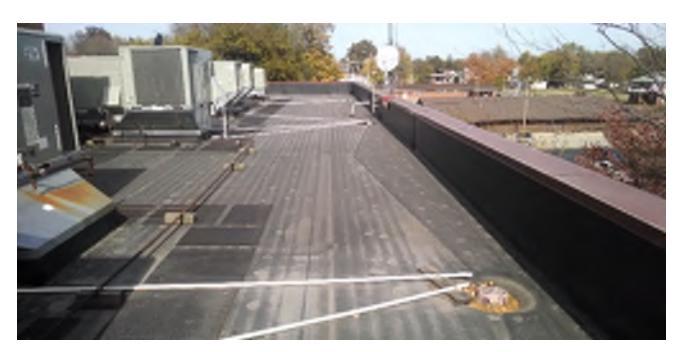
From the interior there was visible evidence of roof leaks at the exterior wall as water stains are present on the ceiling tile and on the walls in the office area as well as the apparatus bay and support spaces. After review of the existing drawings, re-roofing drawings, existing conditions, and feedback from the occupants, it is presumed that the leak issues have been resolved since the re-roof. The existing drawings did not detail the roof membrane to extend and lap over the exterior parapet walls, however the re-roof drawings indicate that this was corrected by lapping the membrane over the parapet and covered with a sheet metal coping cap.

Figure #1-19 Roof membrane laps up parapet wall and under coping cap.

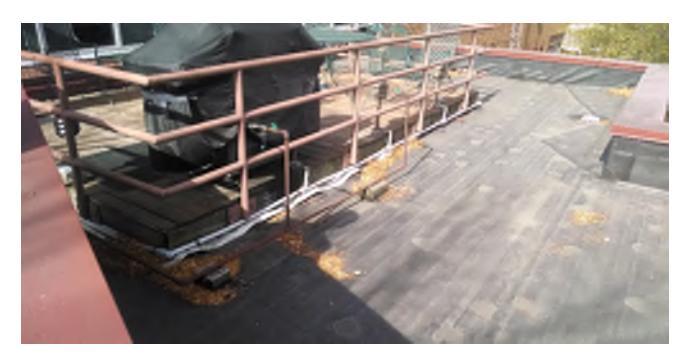
Roof patio deck guard rails are rusting and need to be refinished and repainted with epoxy based primer and paint.

Figure #1-21 Roof patio.

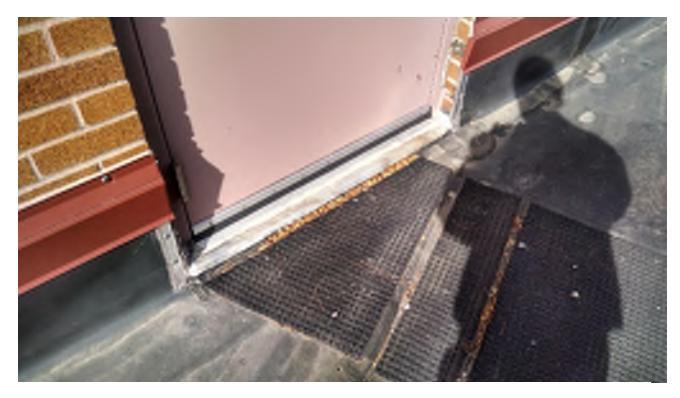
It is typically recommended that the roof membrane flash a minimum of 8" up walls. The hose tower floor is approximately the same elevation of the roof membrane elevation. The door to the roof does not allow any space for membrane flashing and the flashing is not returned into the opening. This condition is a potential leak issue from rain as well as snow drifting.

Figure #1-22 Door from hose tower onto roof. Exposed masonry and insufficient roof flashing height.

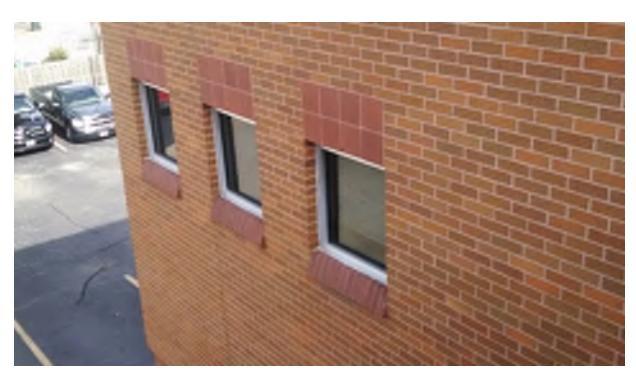
- 2) Despite drawings indicating sill plan flashing, it is possible that sill pan flashing was not installed in all locations (some locations where sill was removed, the sill pan was visible). Without sill pan flashing, water is able divert into the wall or back to the interior.

- 3) Storefront systems drain through the vertical mullions down to the sill and then weeped out to the exterior. It appears that most of the sills were caulked/sealed without any ability to weep. Causing water to back flow to the interior.

Figure #1-23 Storefront windows at sleeping quarters. No apparent sill pan flashing extending to edge of brick & evidence of sealant at window sill preventing weeping.

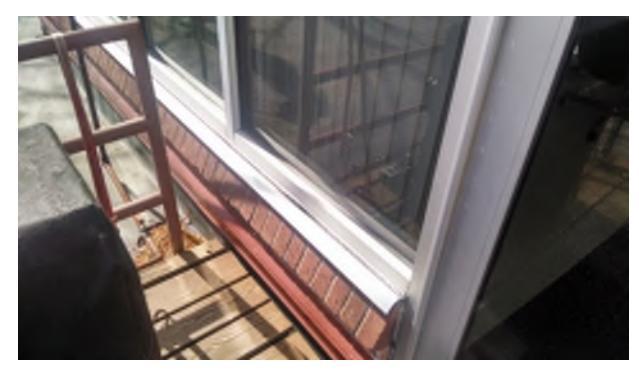
Figure #1-24 Sill flashing provided and extends beyond masonry. Evidence of sealant at window sill preventing weeping.

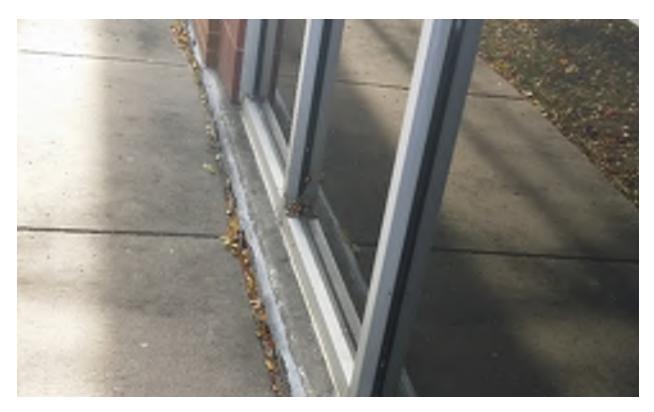
Sill pan flashing was not installed at the base of the storefront systems that sit on the foundation wall at the floor line. Sill pan flashing is highly recommended.

Figure #1-25 Missing sill pan flashing at base of storefront.

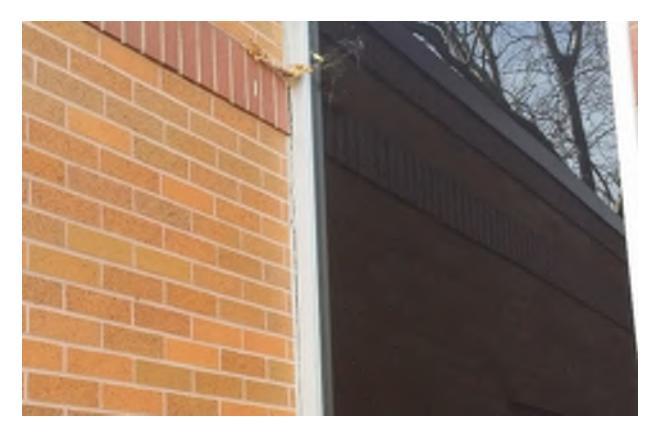
Perimeter sealant joints are failing at windows and doors. Much of the perimeter sealant has lost adhesion and is cracking.

Figure #1-26 Failed perimeter sealant.

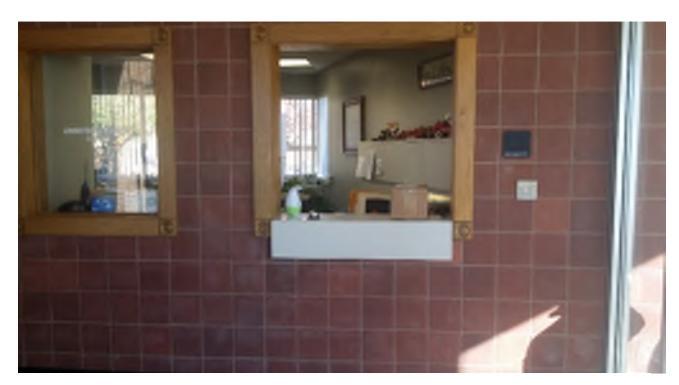
The exposed brick has efflorescence which can be cleaned off, but will return if flashing work at roof is not completed.

Figure #1-28 Efflorescence on 8x8 exposed brick on interior.

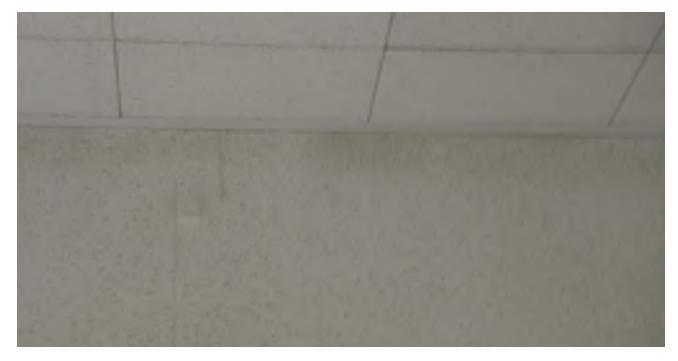
Wallcovering has been removed in many rooms where water infiltration has caused staining, peeling, or damage. There are still locations where there is evidence of past and current water infiltration.

Figure #1-29 Evidence of water infiltration on wall. covering.

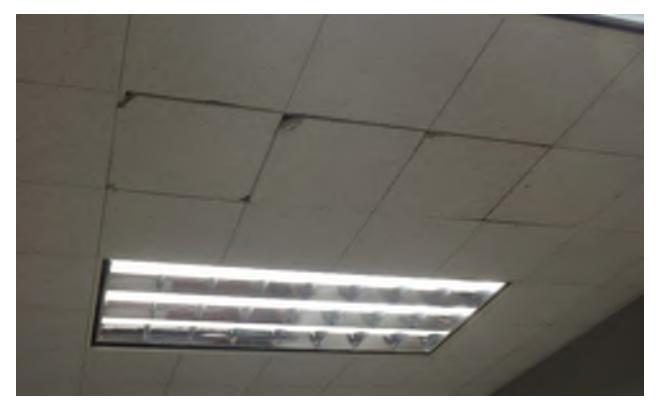
Many of the 1x1 ceiling tiles are stained around the perimeter of the exterior walls where previous or current water infiltration has occurred. There are some locations where the grid has pulled away from the wall causing some loose tile. There are also many locations where tile is missing from technology installations. As can be seen from where tile was removed, concealed tile systems are inconvenient for access to above the ceiling making maintenance and installation of systems above and in the ceiling difficult.

Figure #1-30 1x1 ceiling tile that is damaged from removal for access above ceiling.

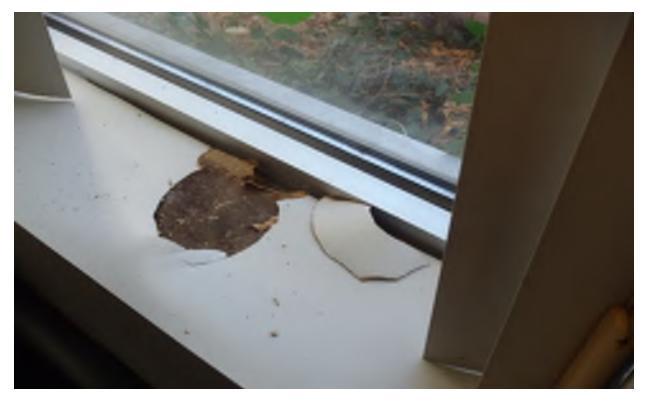
The majority of window sills are plastic laminate and are damaged from water infiltration or condensation (see window comments). Some of the sills have been replaced by the fire department with a solid surface material like Corian, but the gypsum wallboard at the ends of the sills needs to be refinished.

Figure #1-31 Damaged window sill at storefront system.

- 1) Clean masonry after flashing work is completed.
- 2) Remove wall covering from walls and refinish and paint walls.
- 3) Continue with replacing broadloom carpet with carpet tile.
- Replace 1x1 concealed ceiling grid system with 2x2 ceiling tile system to improve access and maintenance.
- 5) Continue to replace damaged window sills with solid surface sills and refinish drywall around opening. Recommend replacing when windows are addressed.

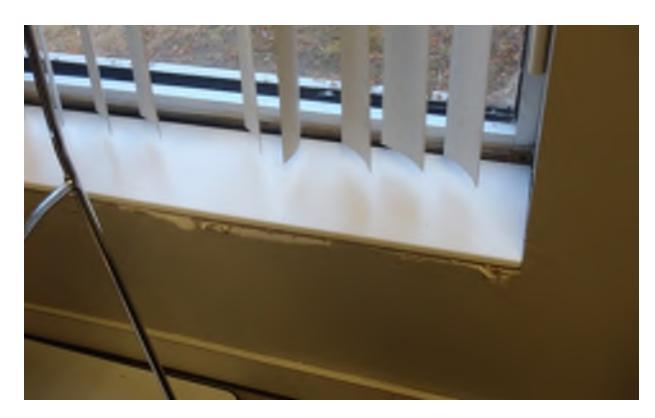
Figure #1-32 Solid surface window sill replacement, unfinished around perimeter.

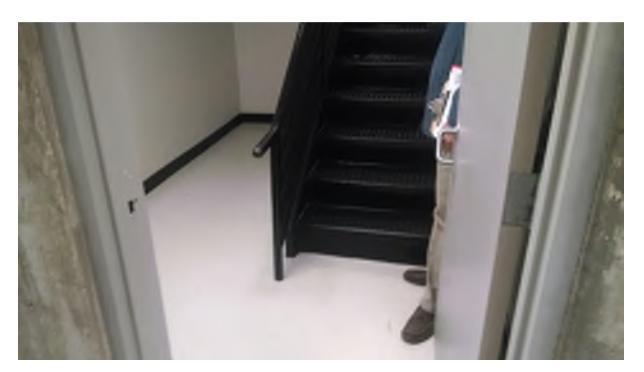
The guardrail heights are 36" and do not meet min. guardrail heights of 42". At the base of the stair the handrail doesn't return as required by ADA and Illinois Accessibility Code.

Figure #1-34 Combination guardrail/handrail at base of stair.

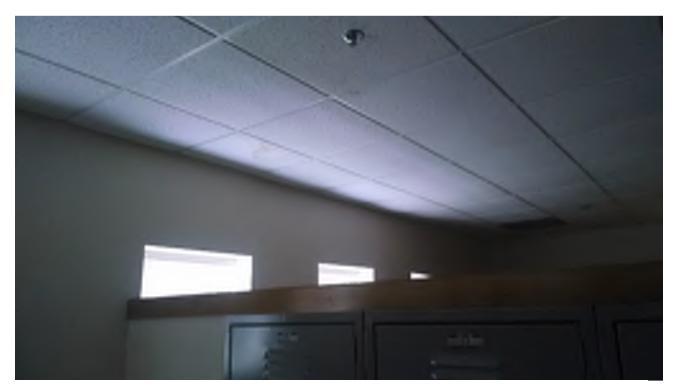
Along the perimeter of the room at exterior walls a number of ceiling tiles are stained.

Figure #1-35 Stained 2x2 ceiling in Sleeping Quarters.

- 1) Refinish and repaint damaged corners and add corner guards.
- 2) Replace stained ceiling tile (Roof leaks were addressed in different section).
- Continue to replace damaged window sills with solid surface sills and refinish drywall around opening. Recommend replacing when windows are addressed.

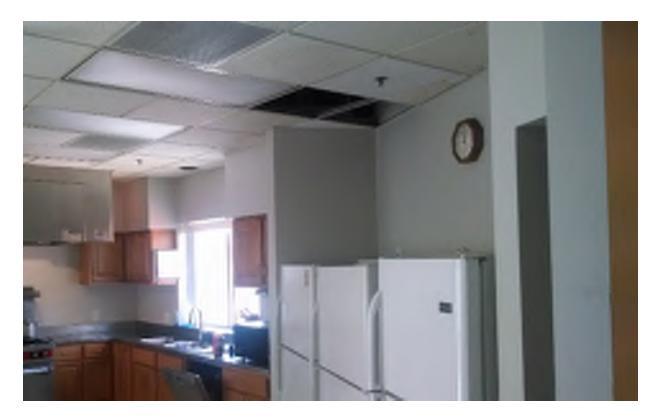
A number of ceiling tiles above the refrigerators have been removed due to constant water leaks. Some other stained tile present.

Figure #1-36 Stained 2x2 ceiling tile and removed ceiling tile where significant roof leak occurs.

- 1) Replace stained ceiling tile (Roof leaks were addressed in different section).
- 2) Provide grease trap and garbage disposer.

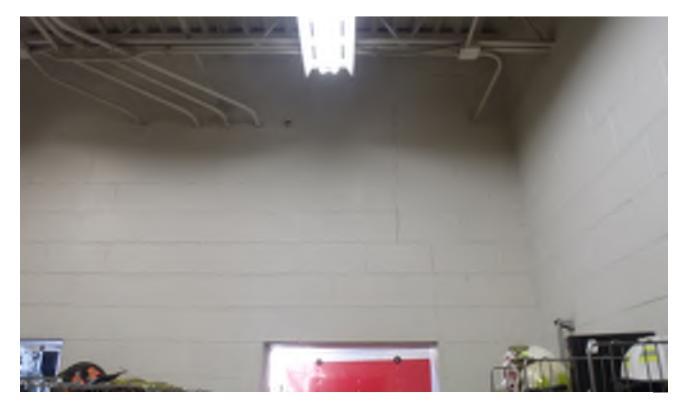
Some shrinkage cracks in the CMU are visible due to lack of control joints at openings.

Figure #1-38 Shrinkage cracks in CMU.

- Repaint apparatus bay, an epoxy based paint is recommended if trucks are washed in apparatus bay.
- 2) Recommend applying a new sealer/hardener to concrete floor and seal cracks. An epoxy floor is an option as well.
- Provide appropriate rated glazing and door assemblies for 1 hr separation where indicated by existing drawings.

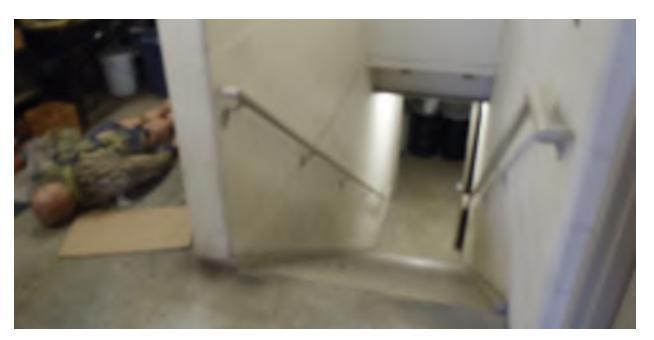
Wing wall at stair to storage basement does not extend beyond end of stair and thus hand rail does not extend past the top step or wrap around the wall.

Figure #1-41 No handrail extension.

- 1) Repaint Apparatus Bay Support Spaces, an epoxy based paint is recommended in washing areas.
- 2) Repoint cracks in CMU.
- 3) Provide penetration fire stopping in rated walls of work room, SCBA room, and storage rooms where indicated on existing walls.
- 4) Provide compliant hardware at rated openings.
- 5) Provide railing that extends beyond top step to meet hand rail requirements.

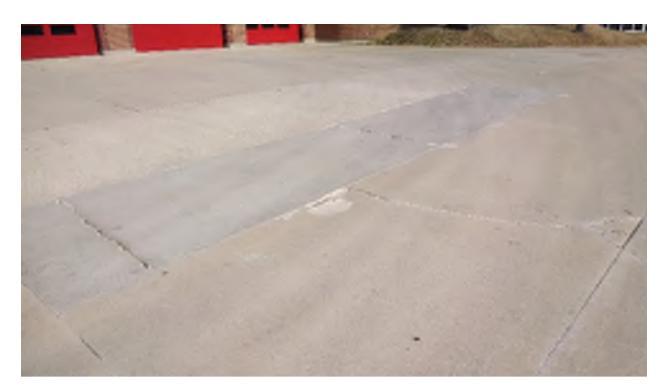
The south side of the building has concrete drives for the apparatus in which some sections are spalling or damaged at edges of the concrete section. Some sections of concrete have surface wear in which the aggregate is beginning to show through. Exposed aggregate and cracks tend to increase the possibility of spalling from freeze thaw cycles and overall deterioration.

Figure #1-42 Patched sections of concrete where deterioration is significant.

- Patch spalled concrete throughout as required to protect exposed aggregate.
- Replace settled concrete drive on north side of building. Compact subgrade and add additional compactable base as required.
- 3) Develop replacement strategy for replacement sections of site concrete paving.
- Replace staff parking lot on north side of building and address site drainage to prevent ponding.
- 5) Replace settled concrete sidewalk on east side of building. Compact subgrade and add additional compactable base as required.

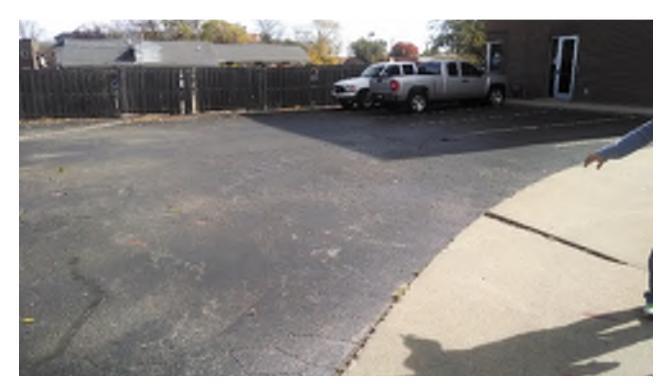
The asphalt parking area on the north side of the building has some locations where the asphalt is deteriorating and coming loose as well as some long cracks. This area is also subject to flooding during heavy rains and when snow and ice melt. This contributes to slippery conditions as well as accelerated deterioration of the paving.

Figure #1-43 Asphalt parking area on north side of building.

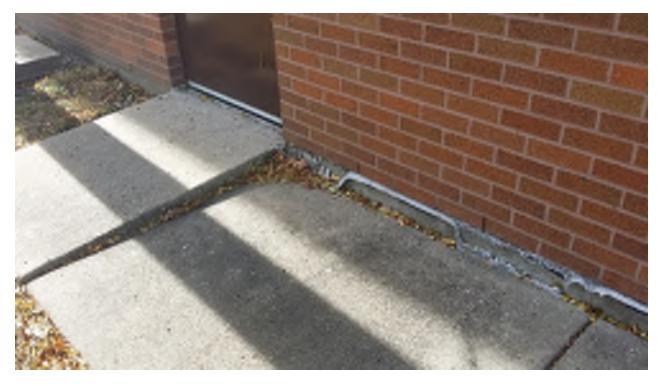
The side walk on the east side of the building has settled significantly. There is evidence of soil erosion below the stoop at the public entrance into the Training Room.

Figure #1-44 Side walk at east side of building has settled significantly.

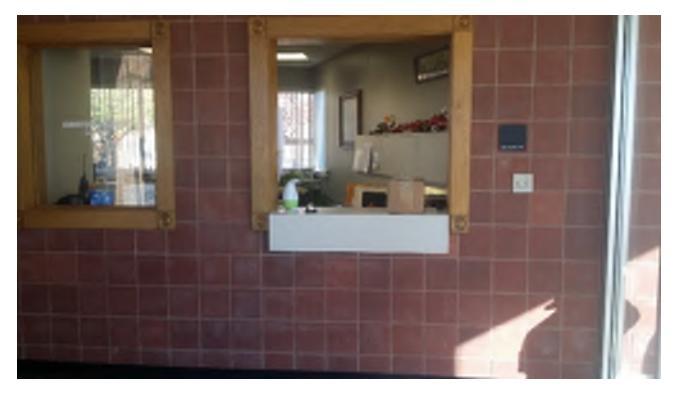
On the first floor, the accessibility issues include lack of a compliant urinal, lavatory countertop required clearances, and mirror heights in the public bathrooms. The reception service countertop is not at the required 34" height. The kitchenette does not have 34" countertop height.

Figure #1-45 Public service counter is not accessible.

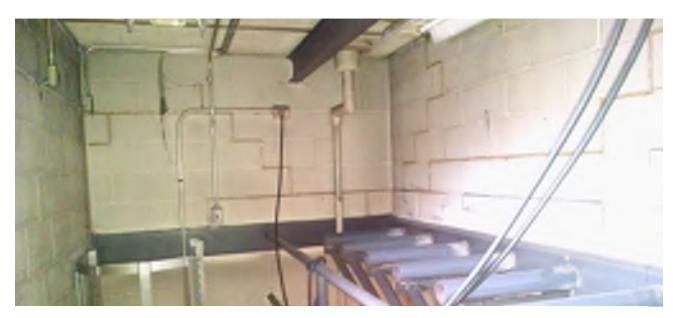
The CMU bearing and partition walls appear to be in fairly good condition throughout the facility. Some stair step pattern and horizontal cracks can be found in the mortar beds of the CMU bearing walls in the apparatus bay. Also, similar style cracking can be found at the top of the hose tower bearing walls. This location has the most extensive structural distress noted onsite and has been sealed in the past to prevent water infiltration. The cracking may be a sign of settlement, shrinkage, or overstress, with the first two issues being common and not a cause of concern. Although, the damage may be indicative of overstress resulting from high lateral loading and/or an insufficient lateral system.

Figure #2-2 Significant cracking at hose tower CMU.

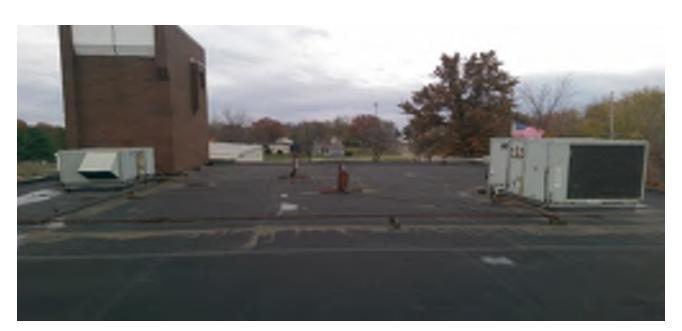
The listed air handling units serving the training area and living quarters are of sizes 10 tons and 7.5 tons respectively. The larger of the two units was installed in 1993, which makes the unit 22 years of age and the second unit was installed in 1997, as of now it is 18 years of age. Each have exceeded the expected length of life according to ASHRAE published data.

Figure #2-3 Station #2 Roof top units above the apparatus bay.

Due to the age of the equipment, Dewberry recommends that the RTU's and space heaters serving the apparatus bay to be replaced for continuous trouble free service. It is also recommended that a reputable duct cleaning service is engaged to do a thorough duct cleaning. The Apparatus Bay roof exhaust fan should be replaced or if not replaced in near future, at least it could use cleaning and a coat of paint and lubricated. The unit can be better installed with proper roof rails attached to the roof. The Toilet and Locker Rooms exhaust fans should be replaced. It was observed that the gas piping on the roof is supported by 4"x4" wood blocks. Through past experience, Dewberry has seen these blocks deteriorate over time resulting in the pipe hanging over long distance without support. It is recommended that MIRO pipe supports – specifically made to support piping - should be used. A coat of paint on the pipe would add durability.

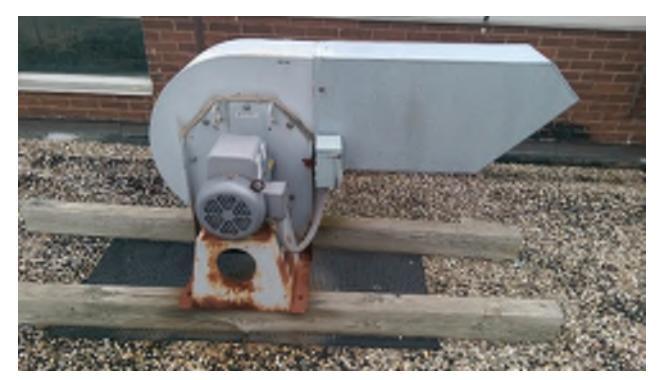
The roof mounted, direct drive exhaust fan serving the Apparatus Bay is mounted on a 4"x4" wood studs and in poor condition. The motor support is rusted.

Figure #2-6 Exhaust fan mounted on 4x4 blocks.

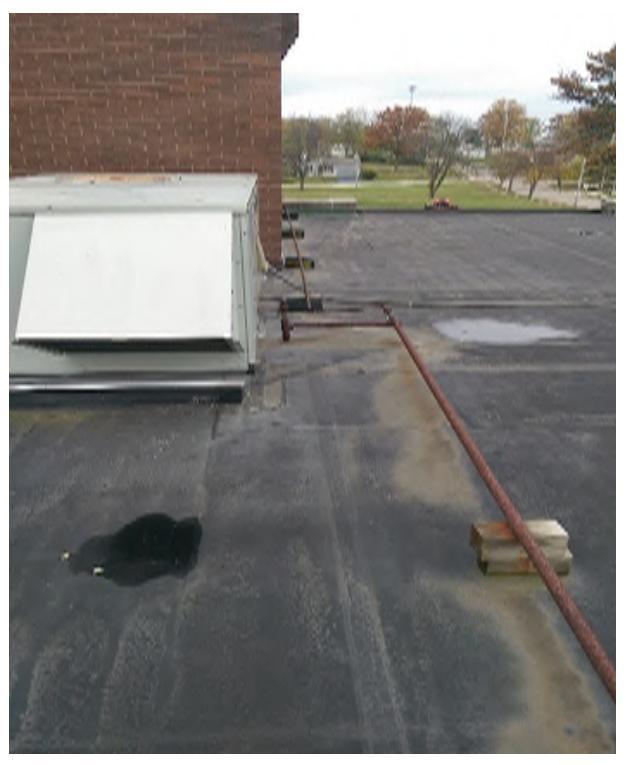
Figure #2-7 Gas lines to mechanical units.

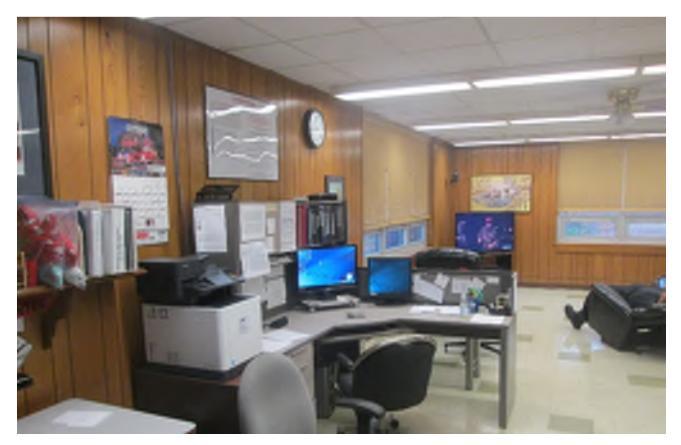
In its present state, the structured cabling system meets the basic operational needs of the department. Hardwired drops are present where they are needed, but there are limited spare drops that prevent support of future systems. Much of the existing structured cabling system has been installed in phases over time and done so in a haphazard manner. The installation does not meet current industry standards and most likely was not tested for performance. As a result, it's questionable whether the cabling system is performing to its optimum level, or if it meets a manufacturer's warranty for performance. Staff also expressed difficulty in identifying active network cable versus cable for other systems or even abandoned cable.

Figure #2-8 Cat 5 cable on wall at work station.

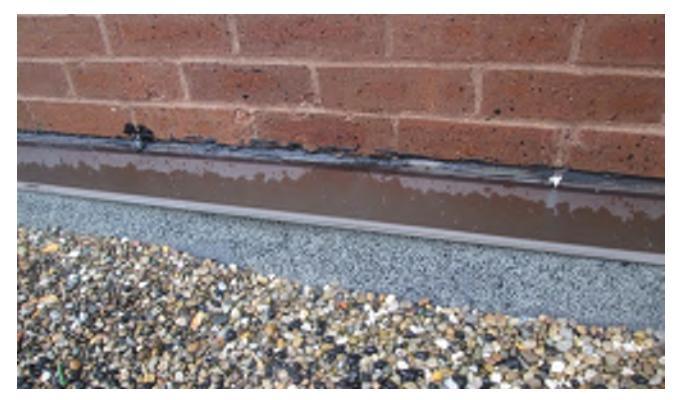
Figure #2-9 Roof to brick masonry transition.

Masonry construction has drip edge at base of wall with regularly spaced weeps and thru wall flashing providing drainage of the cavity wall. However, at the clerestory of the apparatus bay where the roof terminates at the masonry wall drip edge, there was evidence of water infiltration on the interior of the Apparatus Bay.

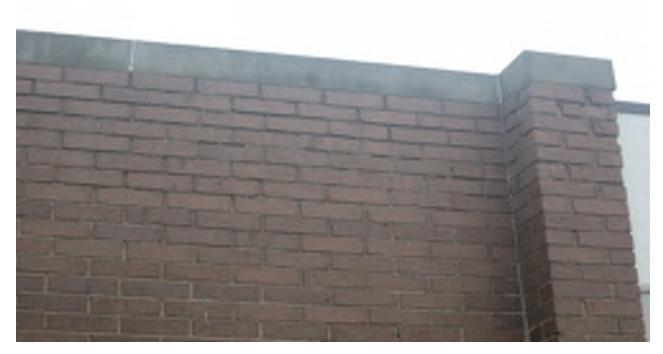
In a few locations on the north side of the building, there is discoloration or a darkening of the masonry indicating the presence of water absorbed into the masonry that is unable to escape through the cavity. There were also spots where brick is spalling and mortar failure.

Figure #2-11 Mortar join failure and brick spalling.

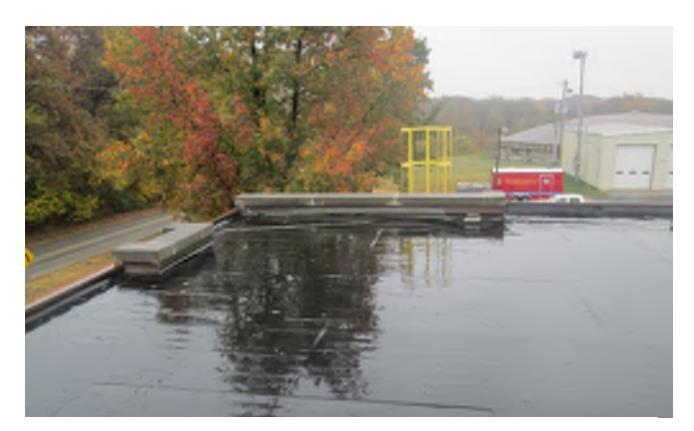
Roof over Apparatus Bay was replaced approximately 7-10 years ago with single ply EPDM membrane system. The typical roof warranty for this system is 20 years. Over all the condition of the roof is in good condition with no visible signs of ponding. The two (2) lower roofs over the recreation area and the living spaces have built up ballasted asphalt roofs that are more than 20 years old and possibly original.

Figure #2-15 EPDM roof above Apparatus Bay.

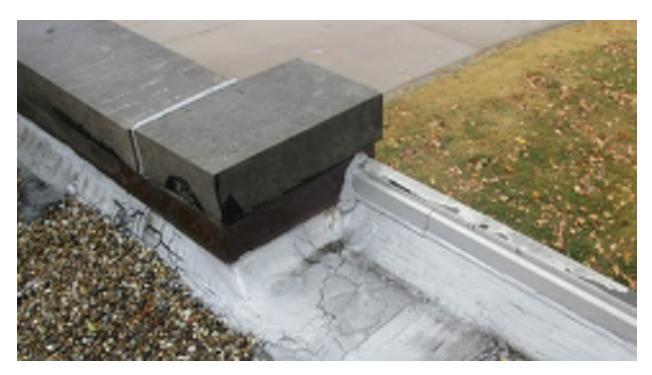
Evidence of leaks are present on the interior side of exterior walls throughout. Based on the construction with a stone coping cap, it is possible there is not thru wall flashing below the coping stone and none of the roofs lap over the top the stone copings. This maybe a primary cause of roof leaks.

Figure #2-16 Stone coping and flashing at ballasted roof.

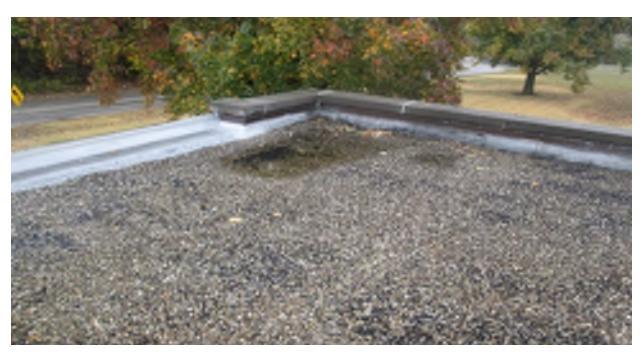
Based on age of the two (2) built up ballasted asphalt roofs, they are past its useful life. These sections of roof also have ponding water from lack of slope and tapering.

Figure #2-17 Ponding on built up ballasted asphalt roof.

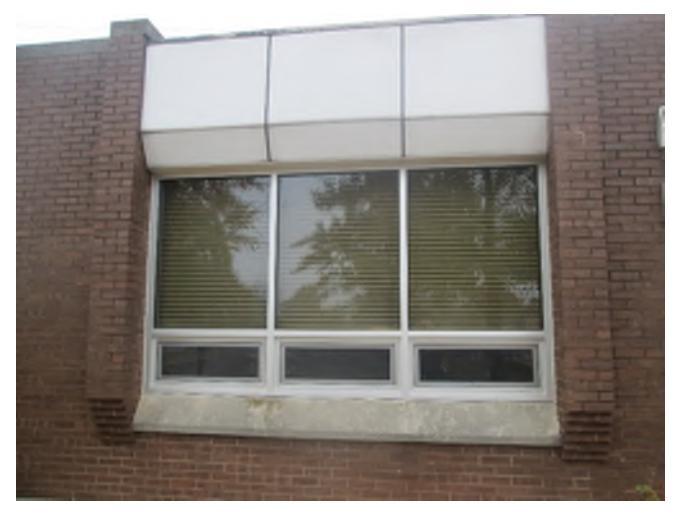
Figure #2-18 Recently installed storefront window system.

Many of the storefront systems have experienced some leaking, likely from lack of sill pan flashing. A few sections of storefront have been replaced at the Day Room and occupants have not noticed water infiltration on the sill as they did before. These 2 window sections were replaced approximately 1-2 years ago. It should be noted the new installations have high performance sill pan flashing which allow the storefront to weep properly.

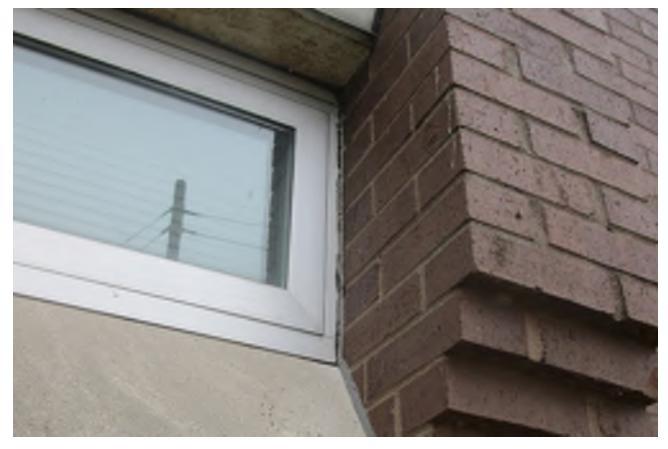
Most of the original sealant around the perimeter of the windows, doors, and overhead doors is failing. They are either losing adhesion or they are hardened and cracked.

Figure #2-19 Failing joint sealant.

- Replace all storefront systems with thermally broken storefront with high performance sill pan flashing and silicone sealant. Provide appropriate compliant hardware.
- 2) Replace hollow metal door with insulated hollow metal door and replace all weather stripping.
- 3) Provide compliant hardware for rated openings.
- 4) Provide compliant glazing for safety glazing and rated glazing.
- 5) Install safety sensors at two (2) overhead doors where they are missing.

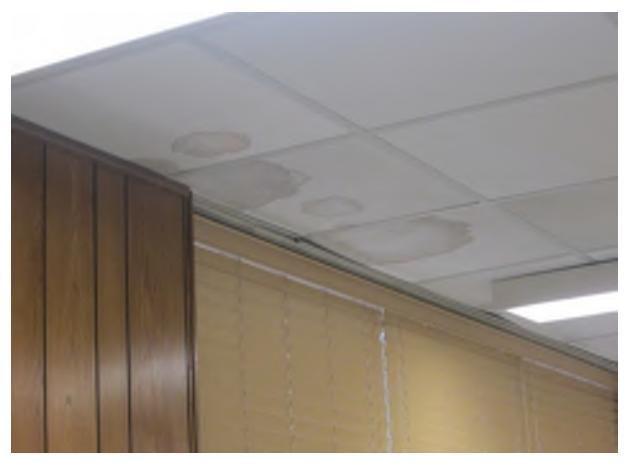
Stained ceiling tile along the perimeter of the exterior walls is present.

Figure #2-20 Stained ceiling tile.

- 1) Replace stained ceiling tile. (Roof leaks were addressed in the roofing section)
- 2) Install carpet in part of Day Room to improve acoustics if intelligibility of call system needs improvement.

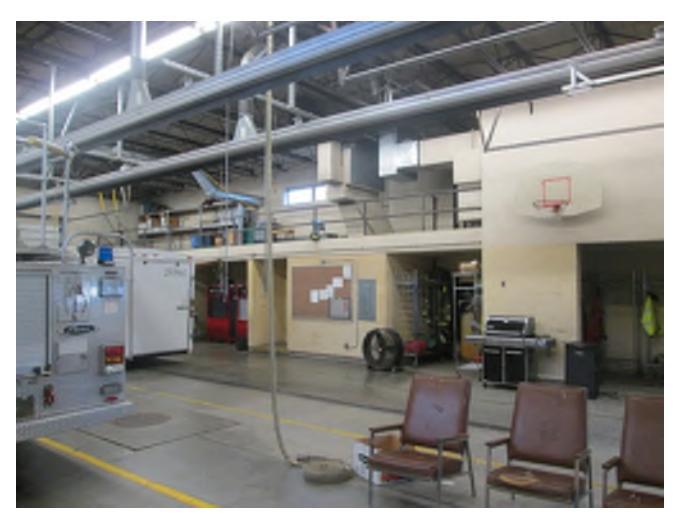
Figure #2-23 Apparatus Bay.

The paint on the walls is fading or discolored. In a few locations the paint is peeling.

Some shrinkage cracks in the CMU are visible due to lack of control joints at openings.

- Repaint Apparatus Bay, an epoxy based paint is recommended if trucks are washed in Apparatus Bay.
- 2) Recommend applying a new sealer/hardener to concrete floor. An epoxy floor is an option as well.
- 3) Verify rating and separation requirements of openings into Apparatus Bay.
- 4) Repoint CMU cracks.

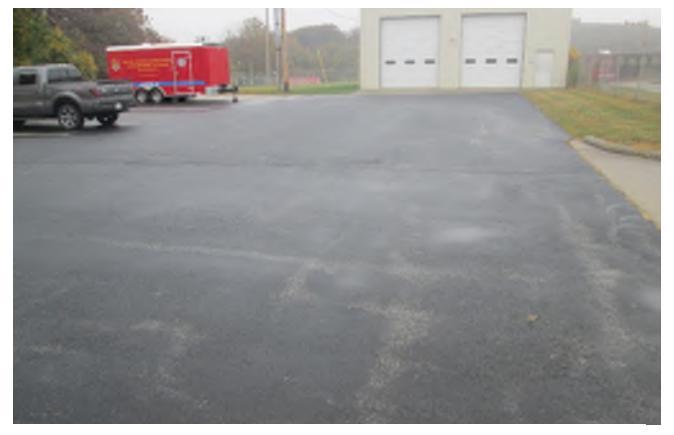
Figure #2-29 Asphalt paved parking.

The asphalt parking lot is in decent condition, but some settlement cracks are continuous through the parking lot.

- 1) Patch any spalled concrete throughout as required to protect exposed aggregate.
- 2) Seal concrete cracks.
- 3) Develop replacement strategy for replacement sections of site concrete paving as they become worn and deteriorate.
- 4) Repair asphalt parking lot cracks, mill-and-overlay parking lot when cracks are beyond repair.
- 5) Replace egress door slab with an elevated slab at the door threshold.

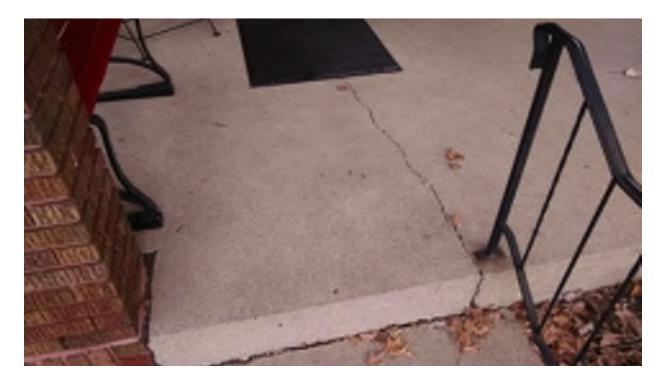
Figure #3-2 Crack in porch slab susceptible to freeze thaw cycles.

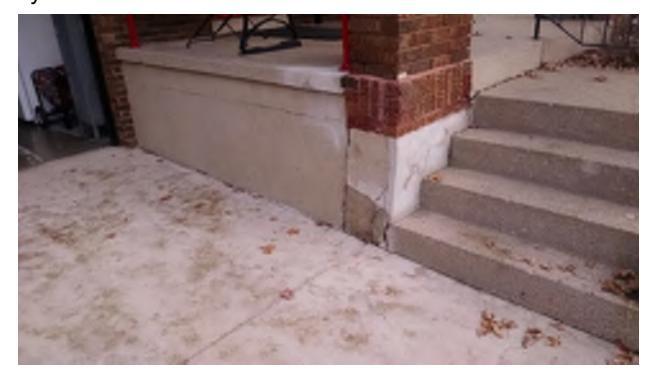
Figure #3-3 Deteriorated concrete foundation pier and horizontal crack through retaining wall.

The front porch does show signs of distress and appears to have had some repair. The concrete slab is supported by a cast-in place concrete wall approximately three feet above grade. Concrete steps lead from the slab down to the entrance drive. A tight horizontal crack stretches along the length of the western wall supporting the stoop. An open and heaved crack exists in the slab running due north and south within the middle third of the slab width. A brick pilaster supports the patio roof and has been tuck-pointed at the elevation of the slab. Also, the concrete pier supporting the pilaster has been patched with a cement grout. The distress apparent in the slab, wall, and pilaster may have been formed from many environmental factors including shrinkage, settlement, and freeze/thaw action. The unsealed joints along the stairway may have also attributed to allowing water infiltration and thus freeze/thaw damage. It is also possible the damage may be caused by other factors.

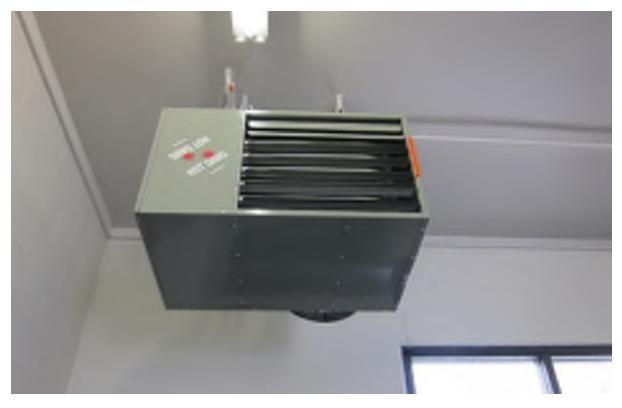
Figure #3-6 Station #3 GUH-1 Apparatus Bay Heater.

In its current condition with scheduled maintenance and service, the unit can provide for the remaining 3-5 years of its expected life.

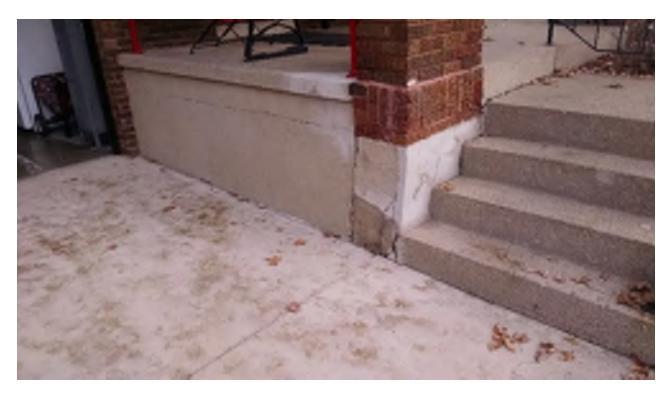
The base of the west porch column is showing signs of deterioration and failure. The mortar joints of the brick base has been recently reworked, but many of the joints are wide and spread apart. At the brick column base, much of the concrete and parging have spalled and re-patched. There is a continuous horizontal crack on the concrete foundation retaining wall on the west part of the porch adjacent to the driveway. Finally the porch concrete slab has a crack from the front of the house to the front of the porch with the west portion of the slab having a slight slope. These all are evidence of the horizontal movement of the slab from freeze/thaw cycles, a settlement issue at the foundation, or foundation failure, see Structural Systems for additional comments.

Figure #3-10 Foundation of brick pier and retaining wall.

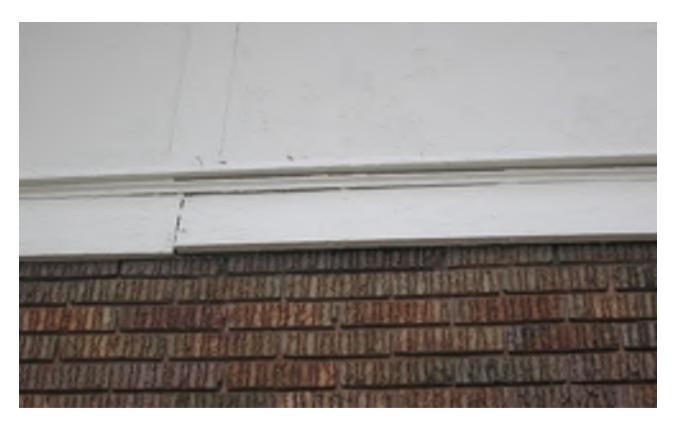
Some of the wood trim at the brick to stucco transition needs to be replaced and/or re-secured. It also appears that the wood cap is the only barrier preventing water from infiltrating behind the brick at the top.

Figure #3-11 Trim boards are not fastened securely.

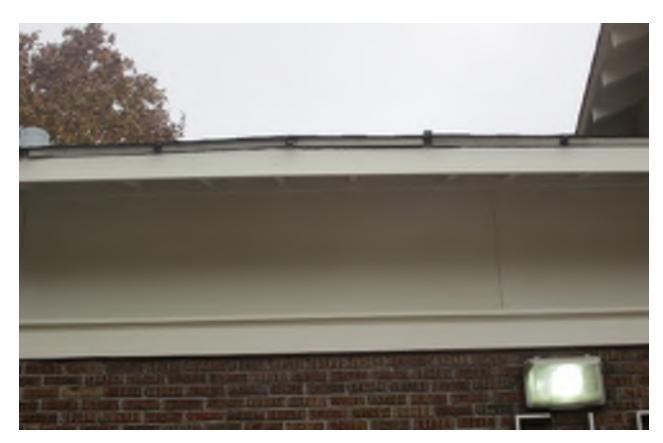
There is some evidence of ice dam damage at eave of roof on the south side of the building.

Figure #3-12 Possible ice dam damage.

The following is a summary of recommended corrective actions for the issues pertaining to the Roof.

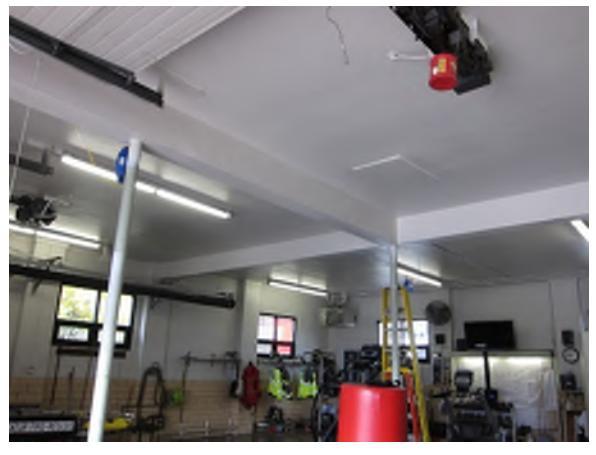
stationed at station #3, limiting the functionality of the station. Evidence of this is the cushion pad placed over the beam wrap for what is assumed protection from apparatus.

Figure #3-19 Station #3 Apparatus Bay.

Apparatus Bay concrete floor sealer has likely worn off and should be reapplied periodically if washing takes place inside.

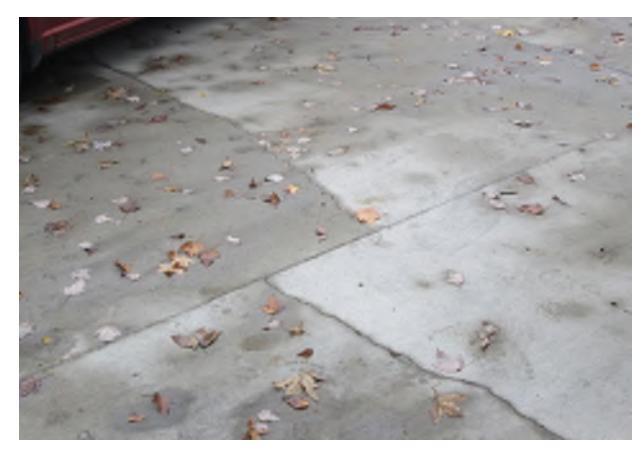
Figure #3-21 Cracking at north concrete parking area.

The site concrete paving on the north parking area and the south Apparatus Bay drive are from early to mid 2000s. The south entrance drive is in good condition with minor cracking. The north parking area has more significant cracking, but no noticeable differential movement.

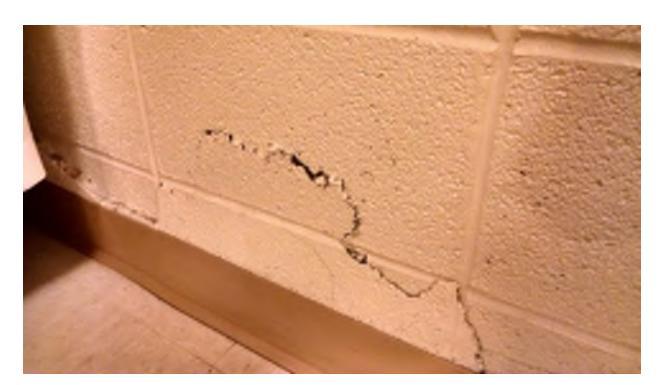
Figure #4-3 CMU is spalling at base of the CMU wall between the Mechanical Storage Room and the Sleeping Quarters.

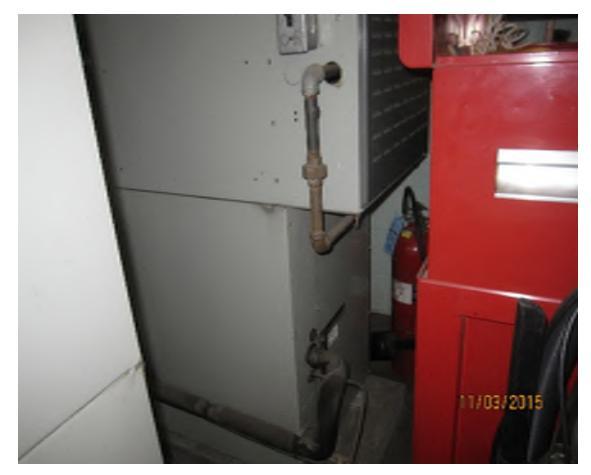
The listed air handling units are in fair condition.

Figure #4-5 Air handling unit in Mechanical Storage Room.

There is no immediate action to replace the units required. With regularly scheduled maintenance – such as lubricating, replacing filters and belts and proper repair – unit will provide remaining 3 to 5 years or more of service.
