Dewberry

Facility Assessment Report

Decatur Fire Department

City of Decatur, Illinois Final Report: February 22, 2016

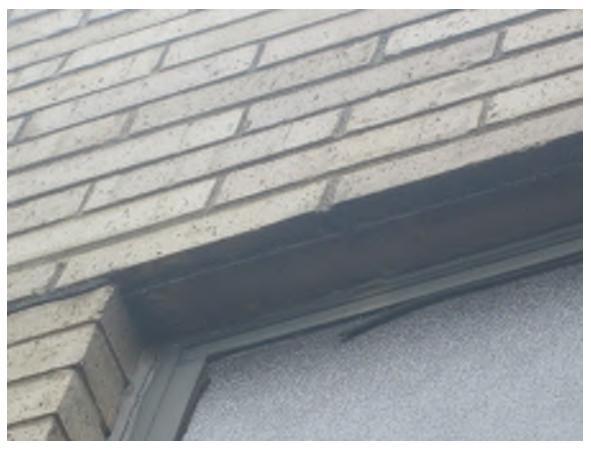
Exterior window glazing is mostly an operable aluminum window system throughout with the exception of the vestibule entrance which is an aluminum storefront system. The remaining entrance doors are wood with wood frames. All window systems are 15+ years old. Some do not operate correctly and are not energy efficient. The window opening frames are wrapped with similar color sheet metal, but are only secured with sheet metal nails which are missing or loose in some locations. The systems are all faded and some gasketing around glazing or panels are failing. Apparatus Bay windows appear to be in the worst condition.

Figure #4-15 Failing gasket in window system.

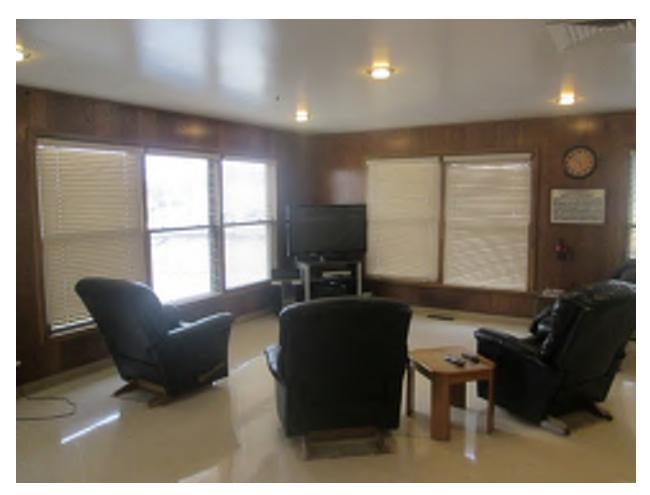
Figure #4-19 Day Room.

The acoustics in the room are not very good for intelligibility of the call speaker system due to hard/reflective surfaces on the floor, wall, and ceiling.

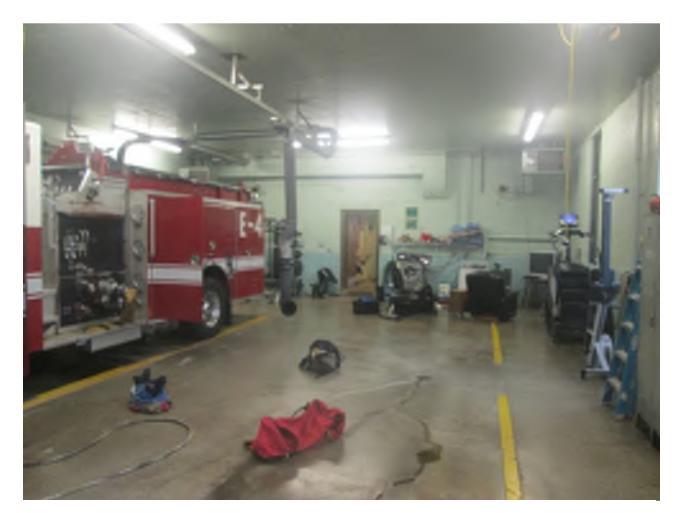
Figure #4-23 Apparatus Bay.

The paint on the walls is fading or discolored. In many locations the paint is peeling.

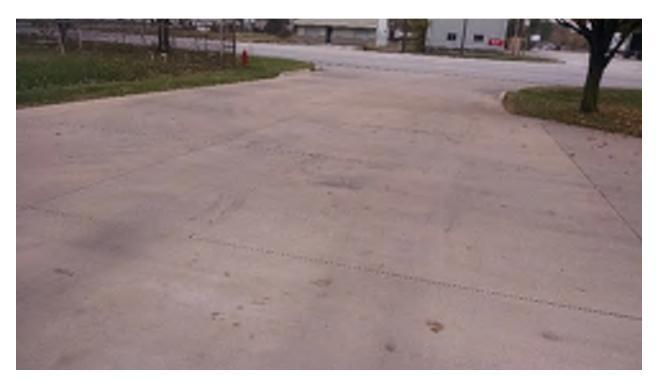
Most of the site concrete is in good condition, but a few sections have a worn surface with exposed aggregate and full length cracks. Exposed aggregate and cracking tends to increases the possibility of spalling from freeze/thaw cycles and overall deterioration.

Figure #4-25 Entrance concrete drive. Some cracking has formed.

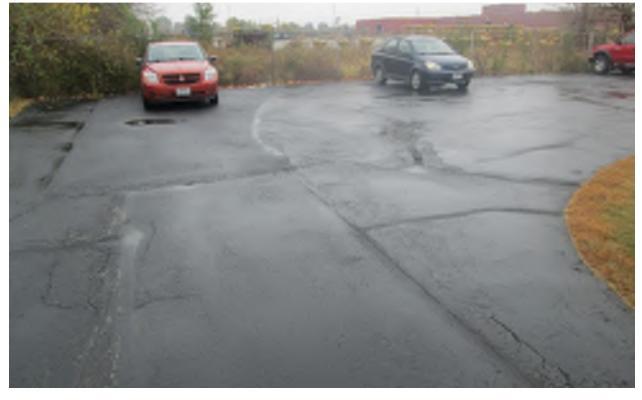
The asphalt parking lot and drive has a fair amount of deterioration, cracks, and some settlement.

Figure #4-26 Asphalt parking lot area with alligator cracking, joint cracks, and some settlement.

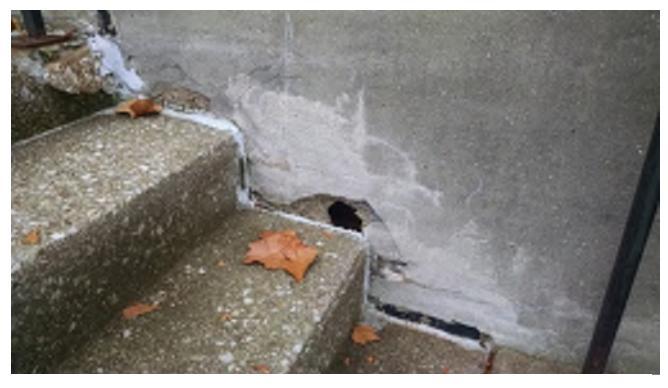
The front entrance vestibule is supported in part by a small concrete wall bounded by the front steps. A hole is apparent in the base of this wall with a void formed behind. It appears that a repair has been conducted in the past to patch the deteriorated area but has spalled away leaving the hole and void open again to the elements. The reason for the damage is not evident but it is clear that rainwater can easily collect behind the wall causing further damage. See the Architectural section for further information and recommendations.

Figure #5-2 Failed foundation wall patch at entrance stair.

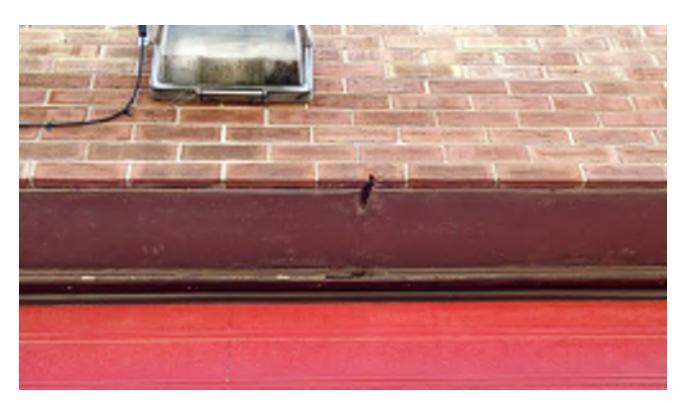
A damaged plate is also apparent above the eastern overhead door at the Apparatus Bay. The steel plate and brickwork appear to have been struck by an object from below leaving an approximately 2" cut through the lintel and crushing the brick above. Studying the original construction documents prepared for Station #6 (constructed very similarly to this facility), it is unclear whether the lintel strength has been compromised. The plate was likely provided as an enclosure and engineered to support the brick above. The cut in the steel plate has reduced the plate's ability to support the brick above.

Figure #5-3 Damaged steel lintel at overhead door opening.

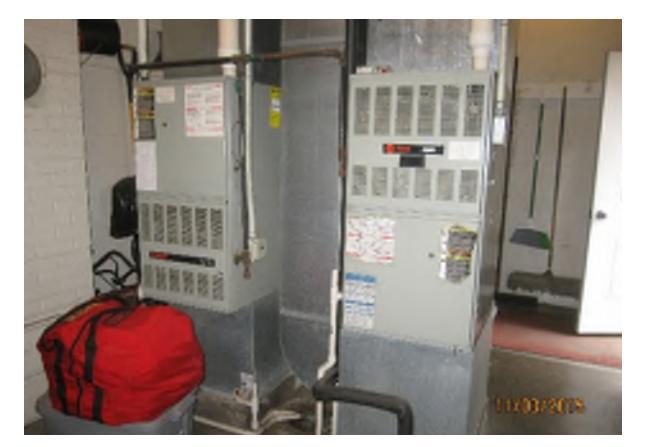
Figure #5-6 Station #5 twin air handling units.

These two Trane units XB90 and XE90 are 90 percent efficient furnaces. There is no immediate action for replacement of these units required. Regularly scheduled maintenance – such as lubricating, replacing filters and belts and proper repair – will provide remaining 3 to 5 years or more of service.

Provide regularly scheduled preventative maintenance for the mechanical equipment to achieve the life expectancy for the system. It is also recommended that a reputable duct cleaning service engaged to do a thorough duct cleaning. Replace equipment at the end of its useful life.

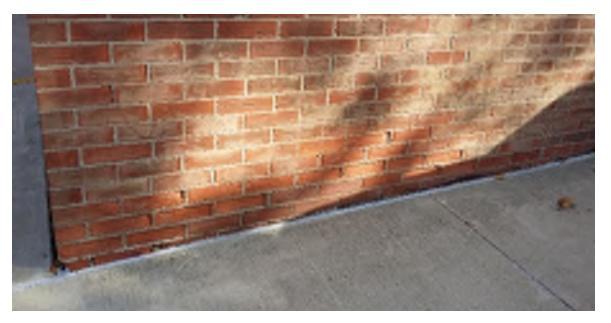
There are also locations where bricks are spalling as a result of constant saturation from poor site drainage conditions. These can be observed on the west, south, and east sides of the building.

Figure #5-8 Spalling bricks at base of wall.

- It is recommended that in conjunction with site drainage recommendations and roof recommendations that at a minimum the brick masonry veneer on the west, south, and east side of the building be stripped and removed to effectively deal with all of the symptoms. From there the following is recommended.
 - a. Allow load bearing CMU wall back up to dry out if showing signs of saturation.
 - b. Install fluid or sheet applied air barrier.
 - c. Install cavity wall brick veneer system with air space by adding foundation to support veneer, utilizing brick ties, install rigid insulation, and thru wall flashing system at base of wall, lintels, and other recommended locations.

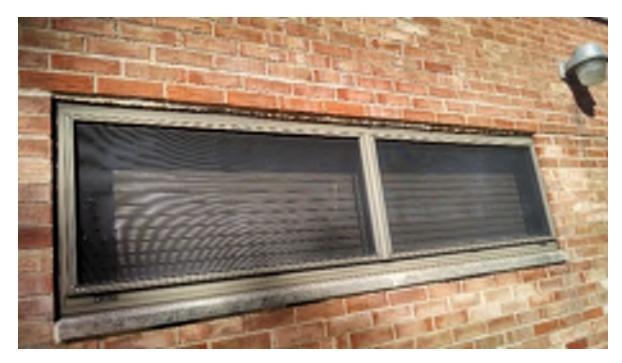
The lintels above windows are rusted and in poor condition, particularly on the south side of the building off of the Day Room, the lintels are sagging/failing.

Figure #5-9 Rusted and failing steel lintel.

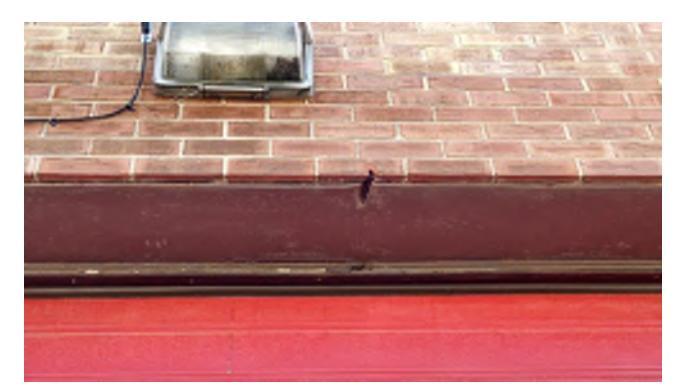
Lintels above overhead doors are rusted with one having some impact damage.

Figure #5-10 Damaged steel lintel at overhead door.

- d. It is recommended that window, doors, and roofs be replaced in conjunction with this work.
- 2) Report brick mortar joints where not replaced.
- 3) Repair damaged lintel at overhead door.
- Replace siding below windows and investigate for further damage in wall.
- 5) Seal mechanical penetrations.
- 6) Replace steps and patch retaining wall. Replace handrails and guardrails.

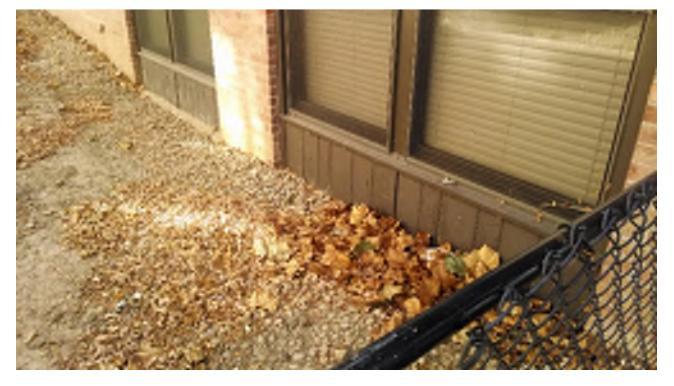
Based on drainage on east side of building, the wood vertical siding at the base of the wall is showing signs of water damaged and deterioration. There is a concerned about water infiltration damage to the interior wall construction. Destructive investigation will be required to determine extent of damage.

Figure #5-11 Site drainage path washout against wood siding.

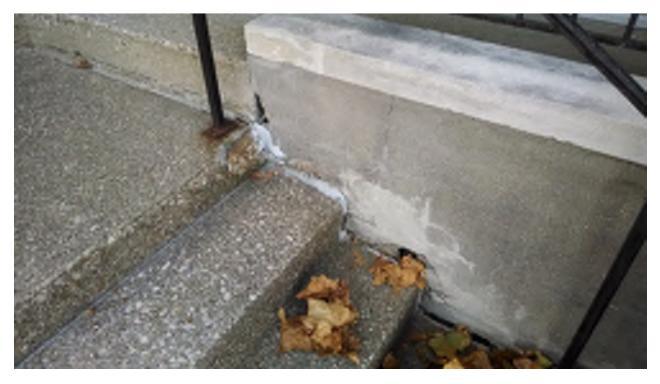
At entrance steps, there is some settlement causing the steps to 'pitch' forward. Likewise the retaining wall at the entrance vestibule has a hole exposed with a void behind it. Visually it appears the cause was from the steps settling.

Handrail and guardrail at steps are rusted, particularly at base.

Figure #5-12 Steps settling and damaged retaining wall.

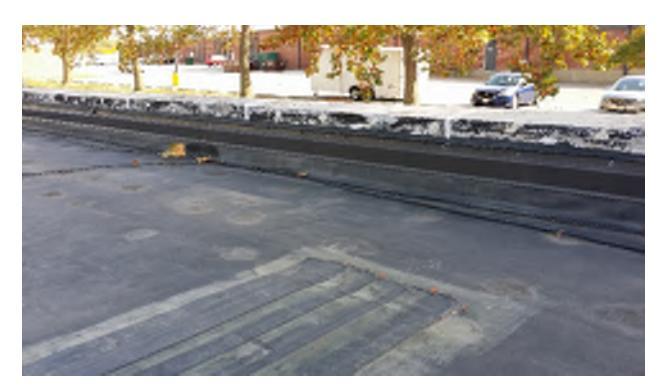
There were some signs of water infiltration on the interior of the Apparatus Bay along the perimeter of the ceiling from roof leaks. This is likely because the roof membrane doesn't lap over parapet coping.

- 1) To resolve the perimeter water infiltration, there are a few actions that could be considered.
 - a. Have a forensic investigation service inspect the roof (Tremco WTI or similar service).
 - b. Replace existing roof and insulation and have perimeter conditions inspected prior to installation of roof. Provide perimeter detail where roof membrane is lapped over top of coping cap and provide coping cap and or roof edge detail.
 - c. Install vapor barrier in conjunction with roof replacement.
 - d. Work should be completed in conjunction with other site drainage work and wall work.

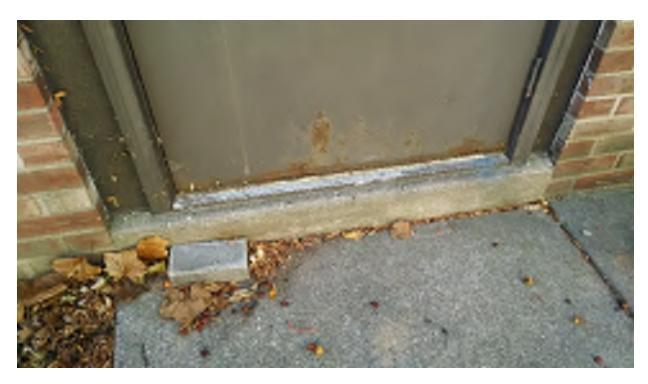
The east exterior door is difficult to open and the base is rusted and deteriorating.

Figure #5-14 Base of door is rusting.

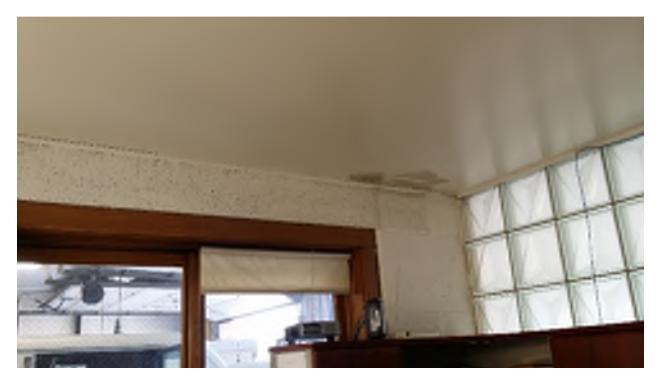
There is peeling paint at the corner of the room adjacent to the glass block likely from water infiltration.

Figure #5-15 Water stain on ceiling in Day Room.

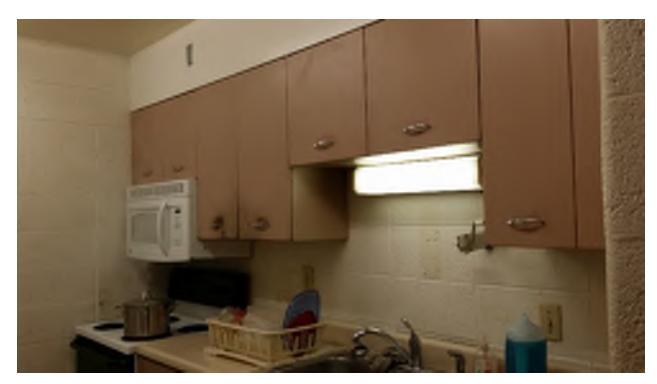
Cabinets are showing signs of wear in hardware and rust in the base of shelves and cabinets. Some of the bases have rusted out completely. Walls are dirty and faded.

Figure #5-16 Kitchen casework.

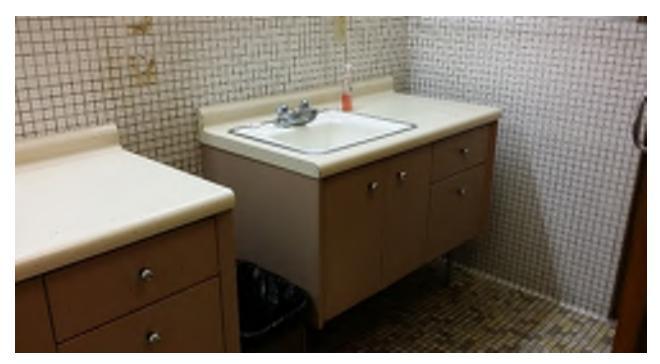
Rust is developing on the side of the toilet partition next to urinal. Some rust is developing on lockers and cabinets.

Figure #5-17 Lavatory cabinets.

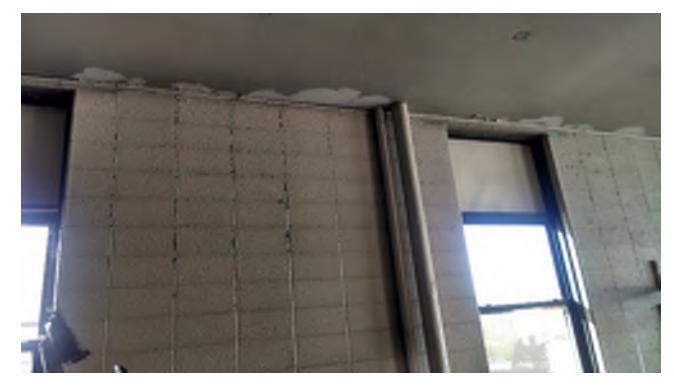
At exterior walls and on the ceilings there is evidence of water infiltration at the roof bearing locations. The leaks are addressed in the Roofing and Building Envelope sections. However, since the space above the hard plaster ceiling is concealed, there is concern of potential mold growth above the ceiling. It should be noted that there is a similar issue and condition at the Sleeping Quarters which revealed a mold issue when the ceiling was removed.

Figure #5-19 Water infiltration in Apparatus Bay.

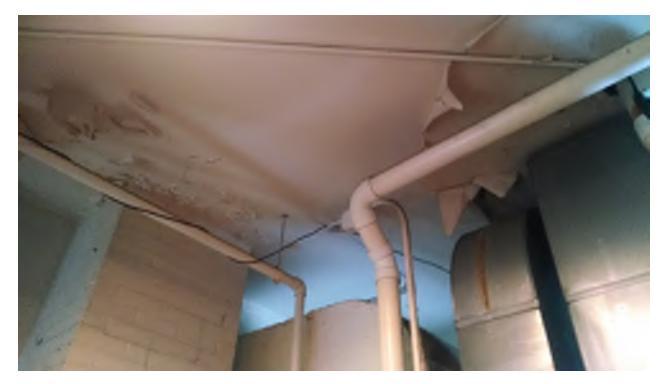
The paint on the walls is fading or discolored. In many locations the paint is peeling.

Figure #5-20 Peeling paint.

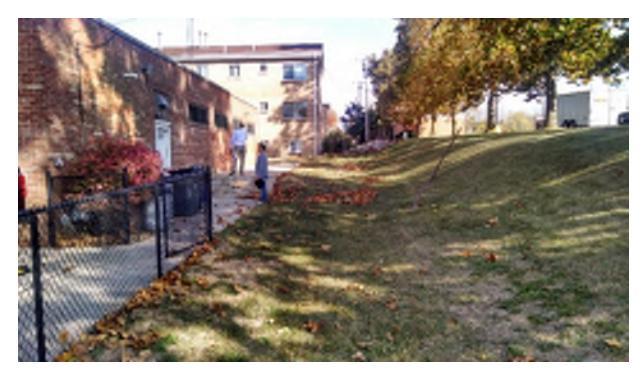
Figure #5-21 Insufficient site drainage on south side.

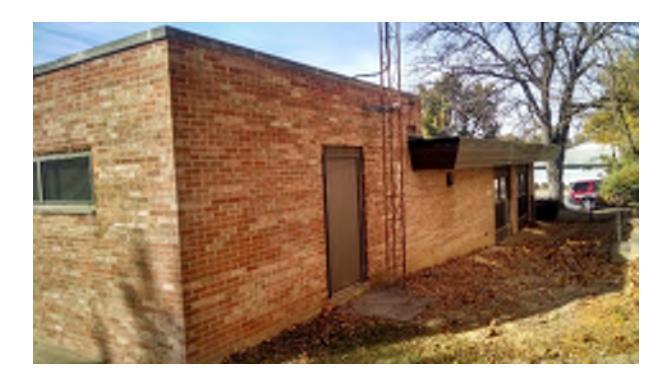
Figure #5-22 Insufficient site drainage at east side of building in between apartment complex.

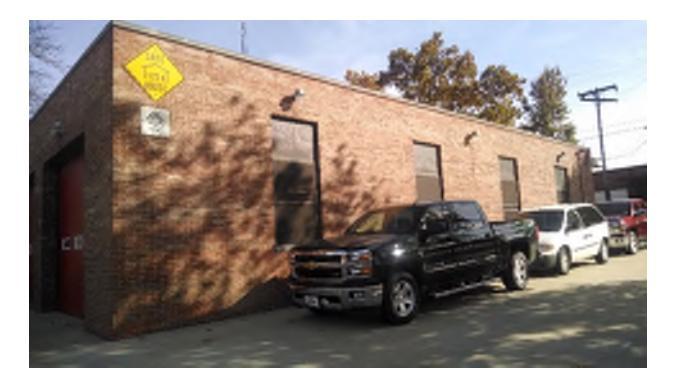
not appear the parking and drive area can be expanded to accommodate independent parking spaces easily.

Figure #5-23 Insufficient parking area.

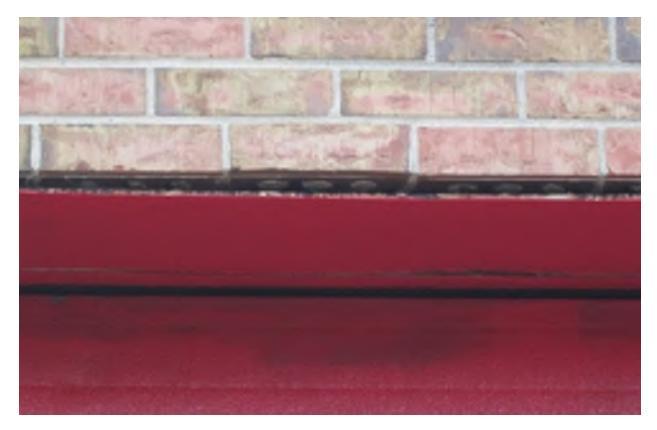
lintel has deflected away from supporting the brick above. The original contract drawings show the lintel construction to include a steel wide flange beam and plate beneath. This plate was likely placed to enclose the opening and to carry the brick veneer load. The facade may now be entirely supported from back-up anchors to the CMU as opposed to the steel plate as designed.

Figure #6-2 Sagging steel lintel at overhead door opening.

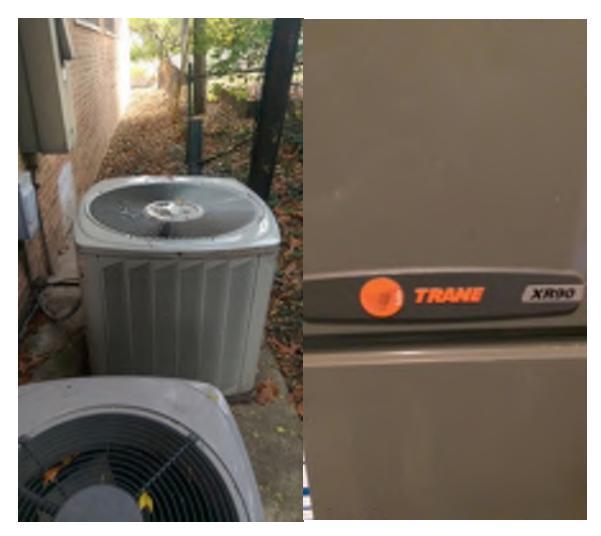
Figure #6-4 Station #6 mechanical condensing unit and air handler.

There is no immediate action for replacement of these units required. Regularly scheduled maintenance – such as lubricating, replacing filters and belts and proper repair – will provide remaining 3 to 5 years or more of service. The gas unit heaters in the Apparatus Bay appear to be in good working order, and do not require immediate repairs or replacement. Apparatus Bay exhaust system is in good condition. No immediate action is required.

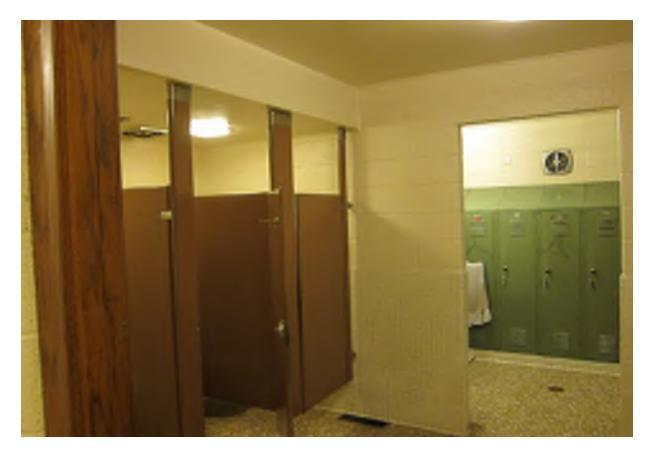
Figure #6-5 Exhaust Fans in Toilet and Locker Room

The exhaust fans in the Toilet and Locker Room are original to the building and have exceeded their anticipated useful life by 2-3 times. These fans no longer operate as originally designed.

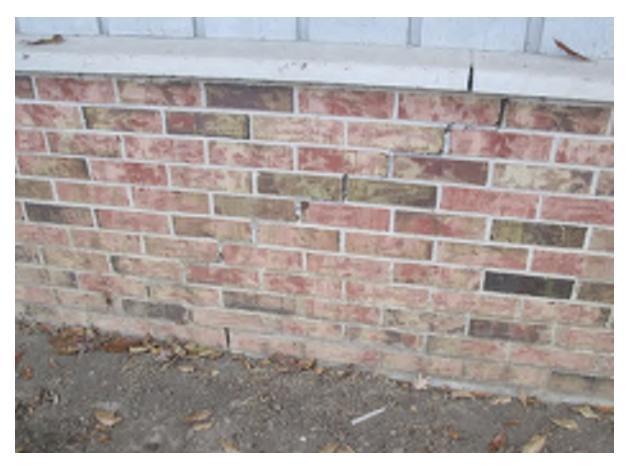
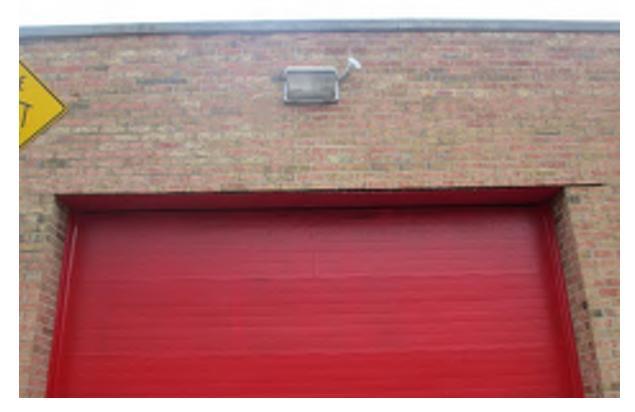
Figure #6-7 Sagging lintels above overhead doors.

Lintels above overhead doors are severely rusted with some sagging. It is likely that the brick is not bearing on steel lintel plate and is dependent on 'arching' of the running bond pattern. The lintels above windows are also rusted.

Figure #6-8 Sagging steel lintels above overhead doors.

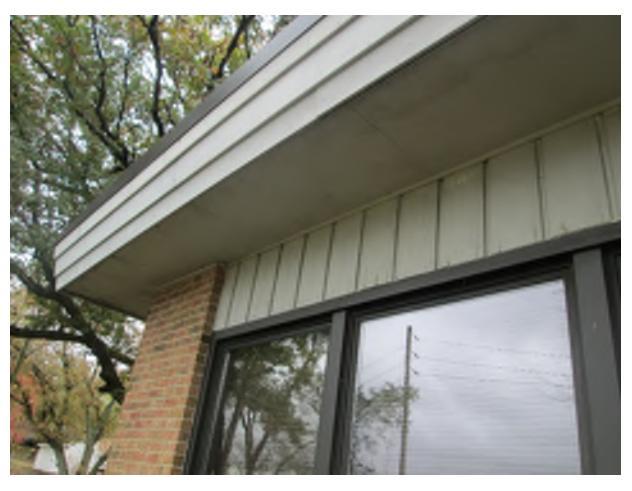
All window systems are approximately 15+ years old. The window opening frames are wrapped with similar color sheet metal. Unlike stations 4 & 5, most of the systems appear to be in better condition with less fading and according to occupants are working properly. The exception is that the Apparatus Bay windows are very difficult to operate, according to the occupants.

Figure #6-10 Aluminum windows and wood siding.

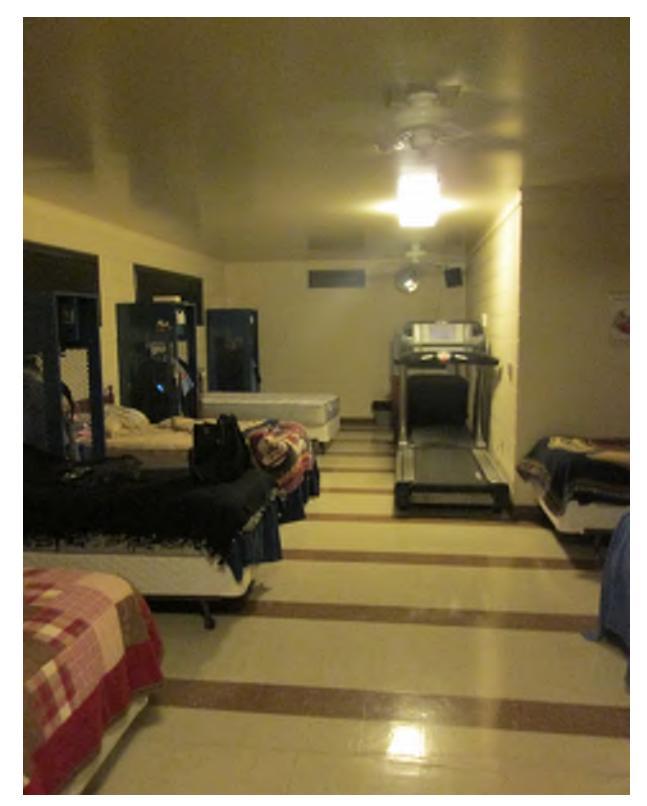
Plaster ceiling has cracks in multiple locations.

Figure #6-14 Sleeping Quarters.

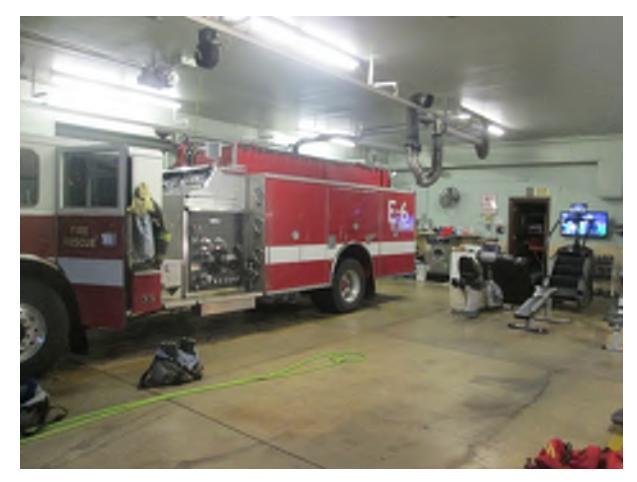
Figure #6-15 Apparatus Bay.

The paint on the walls is fading or discolored. In many locations the paint is peeling.

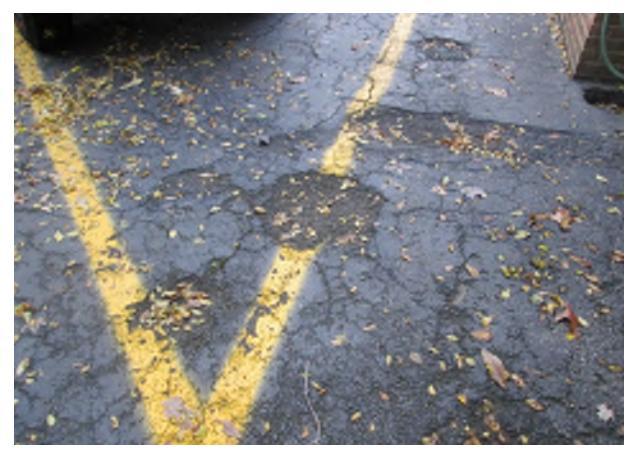
Figure #6-16 Deteriorating asphalt parking lot paving.

The asphalt parking lot has a fair amount of deterioration, cracks, pot holes, and some settlement.

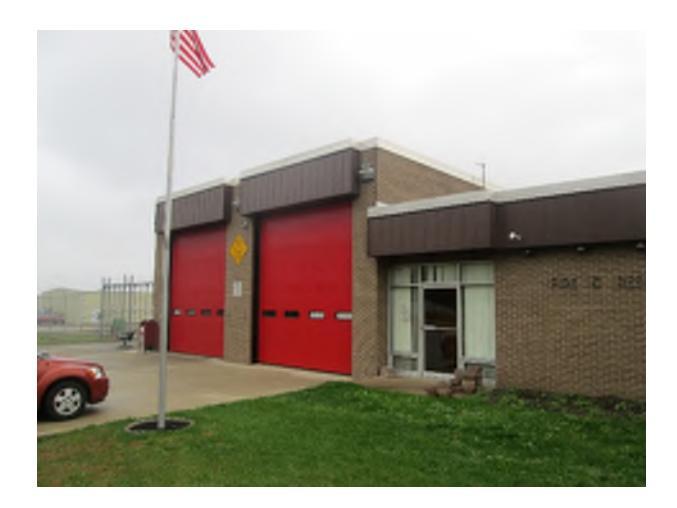
Figure #7-1 Station #7 entrance.

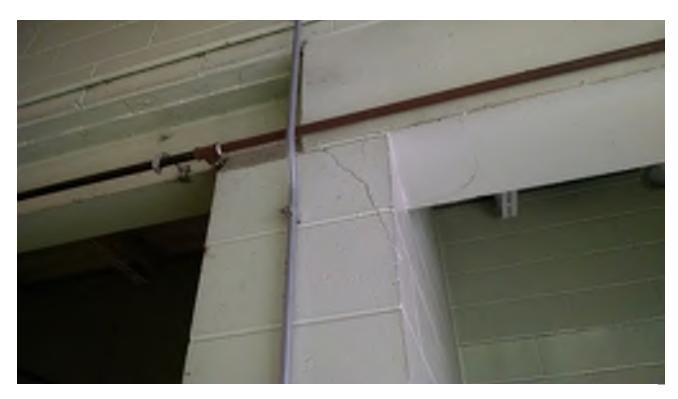
stress seen in the brick veneer may be caused by the CMU wall backup deflecting greater than anticipated. There does appear to be areas of significant cracking in all of the CMU walls around the Apparatus Bay. Some cracks are visible along the north and south walls forming a stair step pattern. Precast lintels provide support for the northern wall. At two instances, a crack through the mortar joint is apparent between two adjacent lintels setting on pilasters. Also, the two easternmost pilasters along the northern wall have a cracked bearing point through the block. Noteworthy horizontal joint bed cracks are apparent in-line with the lower roof. This is likely the location of a masonry bond beam with horizontal reinforcing and is also a location of differential temperature. Vertical cracks appear consistently from the roof level down to the lower roof level line. These cracks may be indicative of shrinkage.

Figure #7-3 Continuous crack through masonry below and above concrete lintel.

Dewberry recommends that visible cracks in the CMU should be sealed to prevent water intrusion. Dewberry also recommends reconstruction of the two CMU pilasters along the North wall of the Apparatus Bay. This will require shoring the existing CMU lintels, removing existing cracked CMU block in the pilasters, and replacing with sound units. Steel reinforcing may be required at the discretion of the design engineer. A proposed design and construction sequence should be designed by a licensed structural engineer with experience in masonry construction. Reconstruction of the pilaster will provide adequate bearing for the lintel.

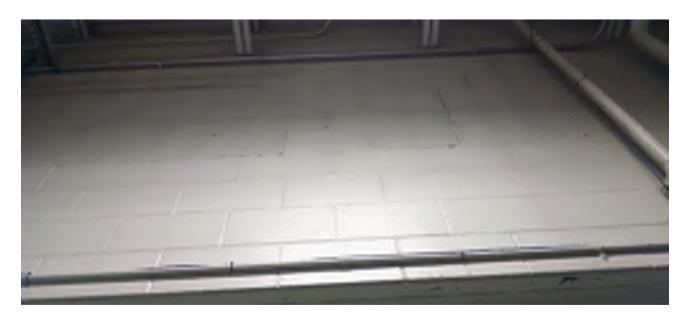
Figure #7-4 Horizontal cracking at CMU.

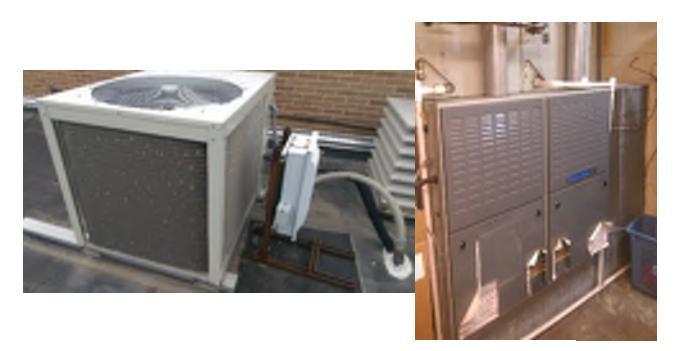
This equipment is fashioned in such a way that a single 10 ton condensing unit is serving two five ton indoor air units. This 2005 installation is 10 years old; no immediate action for replacement of these units required. The rooftop exhaust fan seems in poor condition and may need replacement in near future. Regularly scheduled maintenance – such as lubricating, replacing filters and belts and proper repair – will provide remaining 3 to 5 years or more of service for the major equipment. It is also recommended that a reputable duct cleaning service engaged to do a thorough duct cleaning.

Figure #7-6 Air handling unit and condensing unit.

Provide regularly scheduled preventative maintenance for the mechanical equipment to achieve the life expectancy for the system. It is also recommended that a reputable duct cleaning service engaged to do a thorough duct cleaning. Replace equipment at the end of its useful life.

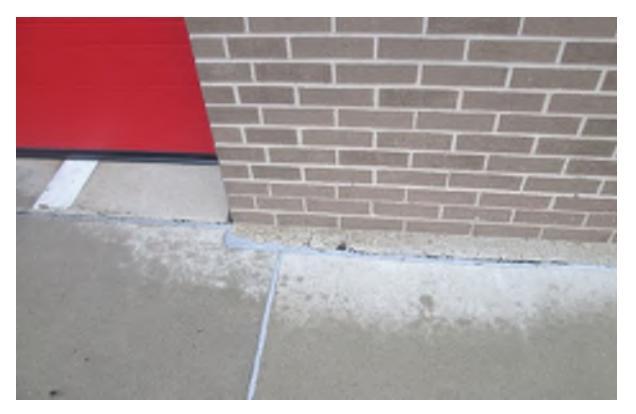
On the east and north side of the building, the brick shows signs of repeated water infiltration without a means of escaping the facility. Particularly where there isn't an overhang, however it should be noted that at the time of the observation it was raining. In addition to the saturated brick, there are many weathered and failing mortar joints.

Assuming that this system is indeed a cavity wall with an air space, there should be thru wall flashing and weeps at the base of the brick wall, at roof to wall transitions, as well as above openings. None were observed. This would contribute to the saturated brick if water is collecting in the cavity wall and mortar joints are failing. It can also contribute to water infiltration at roof to wall transitions if no thru wall flashing is provided.

Figure #7-9 No thru wall flashing with weeps.

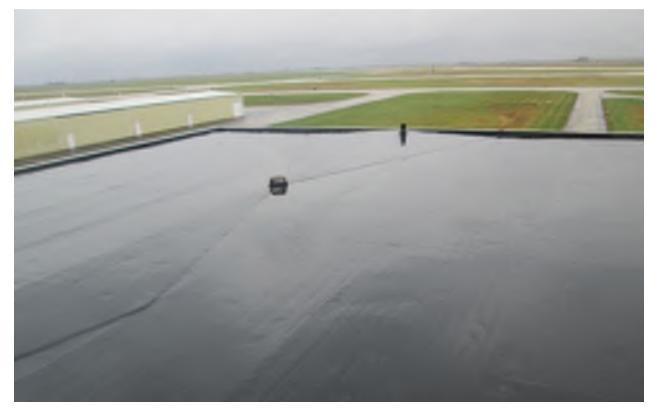
The roof was replaced approximately 7-10 years ago with single ply EPDM membrane system. The typical roof warranty for this system is 20 years. The membrane is in good condition. There is good drainage provided with crickets and the edge terminations are done well.

Figure #7-11 EPDM membrane roof.

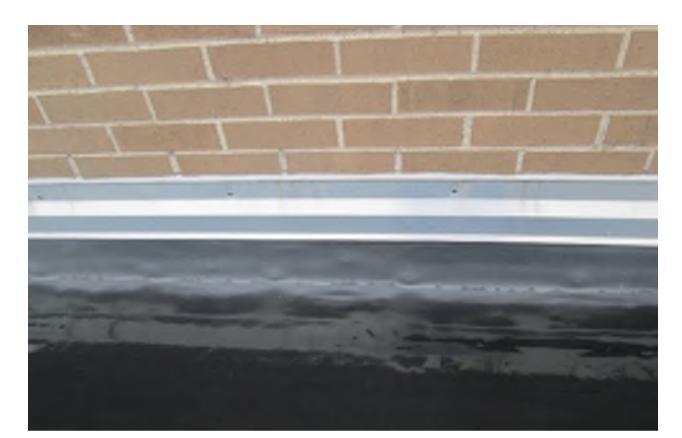
Figure #7-12 Missing thru wall flashing.

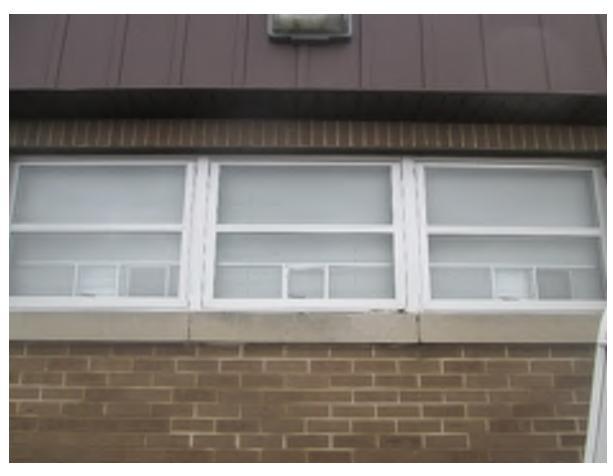
The storefront systems have experienced repeated water infiltration which is likely due to age of system, lack of sill pan flashing, and no weeps at base of storefront. The worst section of storefront has been replaced at the Day Room and occupants have not noticed water infiltration. It should be noted the new installations have high performance sill pan flashing which allow the storefront to weep properly.

Occupants also complain of the air infiltration and 'drafty' nature of the windows and the exterior doors, especially in the Sleeping Quarters.

Figure #7-13 Storefront system at sleeping quarters.

It appears that the storefront systems are original to the building and assumed not to be thermally broken systems. It appeared that the insulated glazing units had bugs in the air space which indicates failed seals in the glazing units.

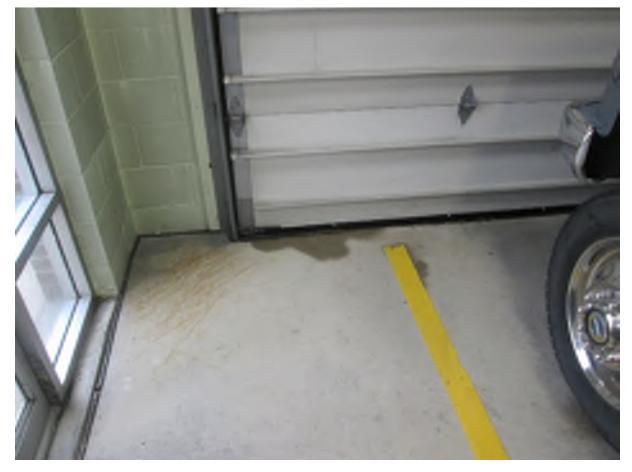
Three (3) of the Apparatus Bay overhead doors are missing the safety sensors at base of door.

Figure #7-16 Water infiltration at overhead door and missing safety sensor.

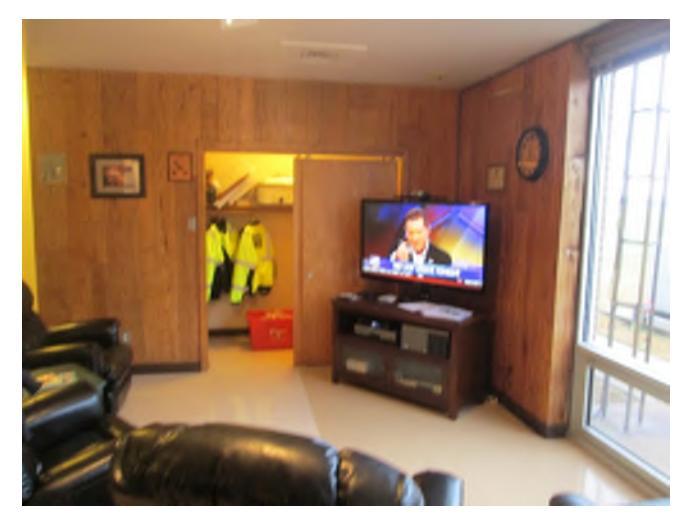
Some VCT was recently replaced due to water infiltration at storefront. The storefront has recently been replaced. The acoustics in the room are not very good for intelligibility of the call speaker system due to hard/reflective surfaces on the floor, wall, and ceiling.

Figure #7-17 Day Room with full height storefront glazing system.

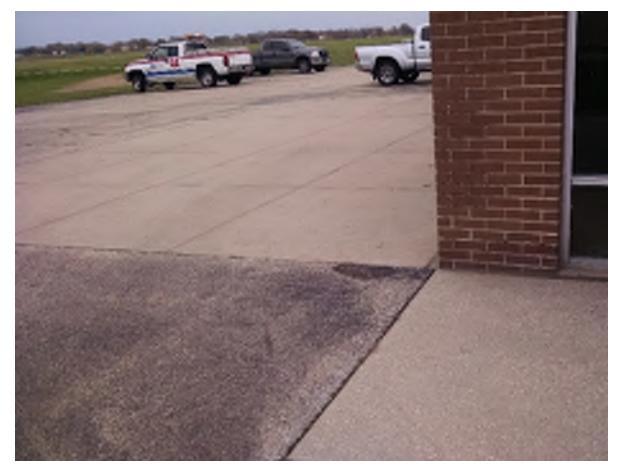
The asphalt parking lot and drive are aged and have a fair number of cracks, but have been sealed. Not many locations showing depressions or settlement.

Figure #7-24 East asphalt parking and concrete drive
